NCDOT NC 12 Response Post Hurricane Irene Aug. 28 – Oct. 10, 2011

NC 12 Damage Assessment from Hurricane Irene, Aug. 27, 2011

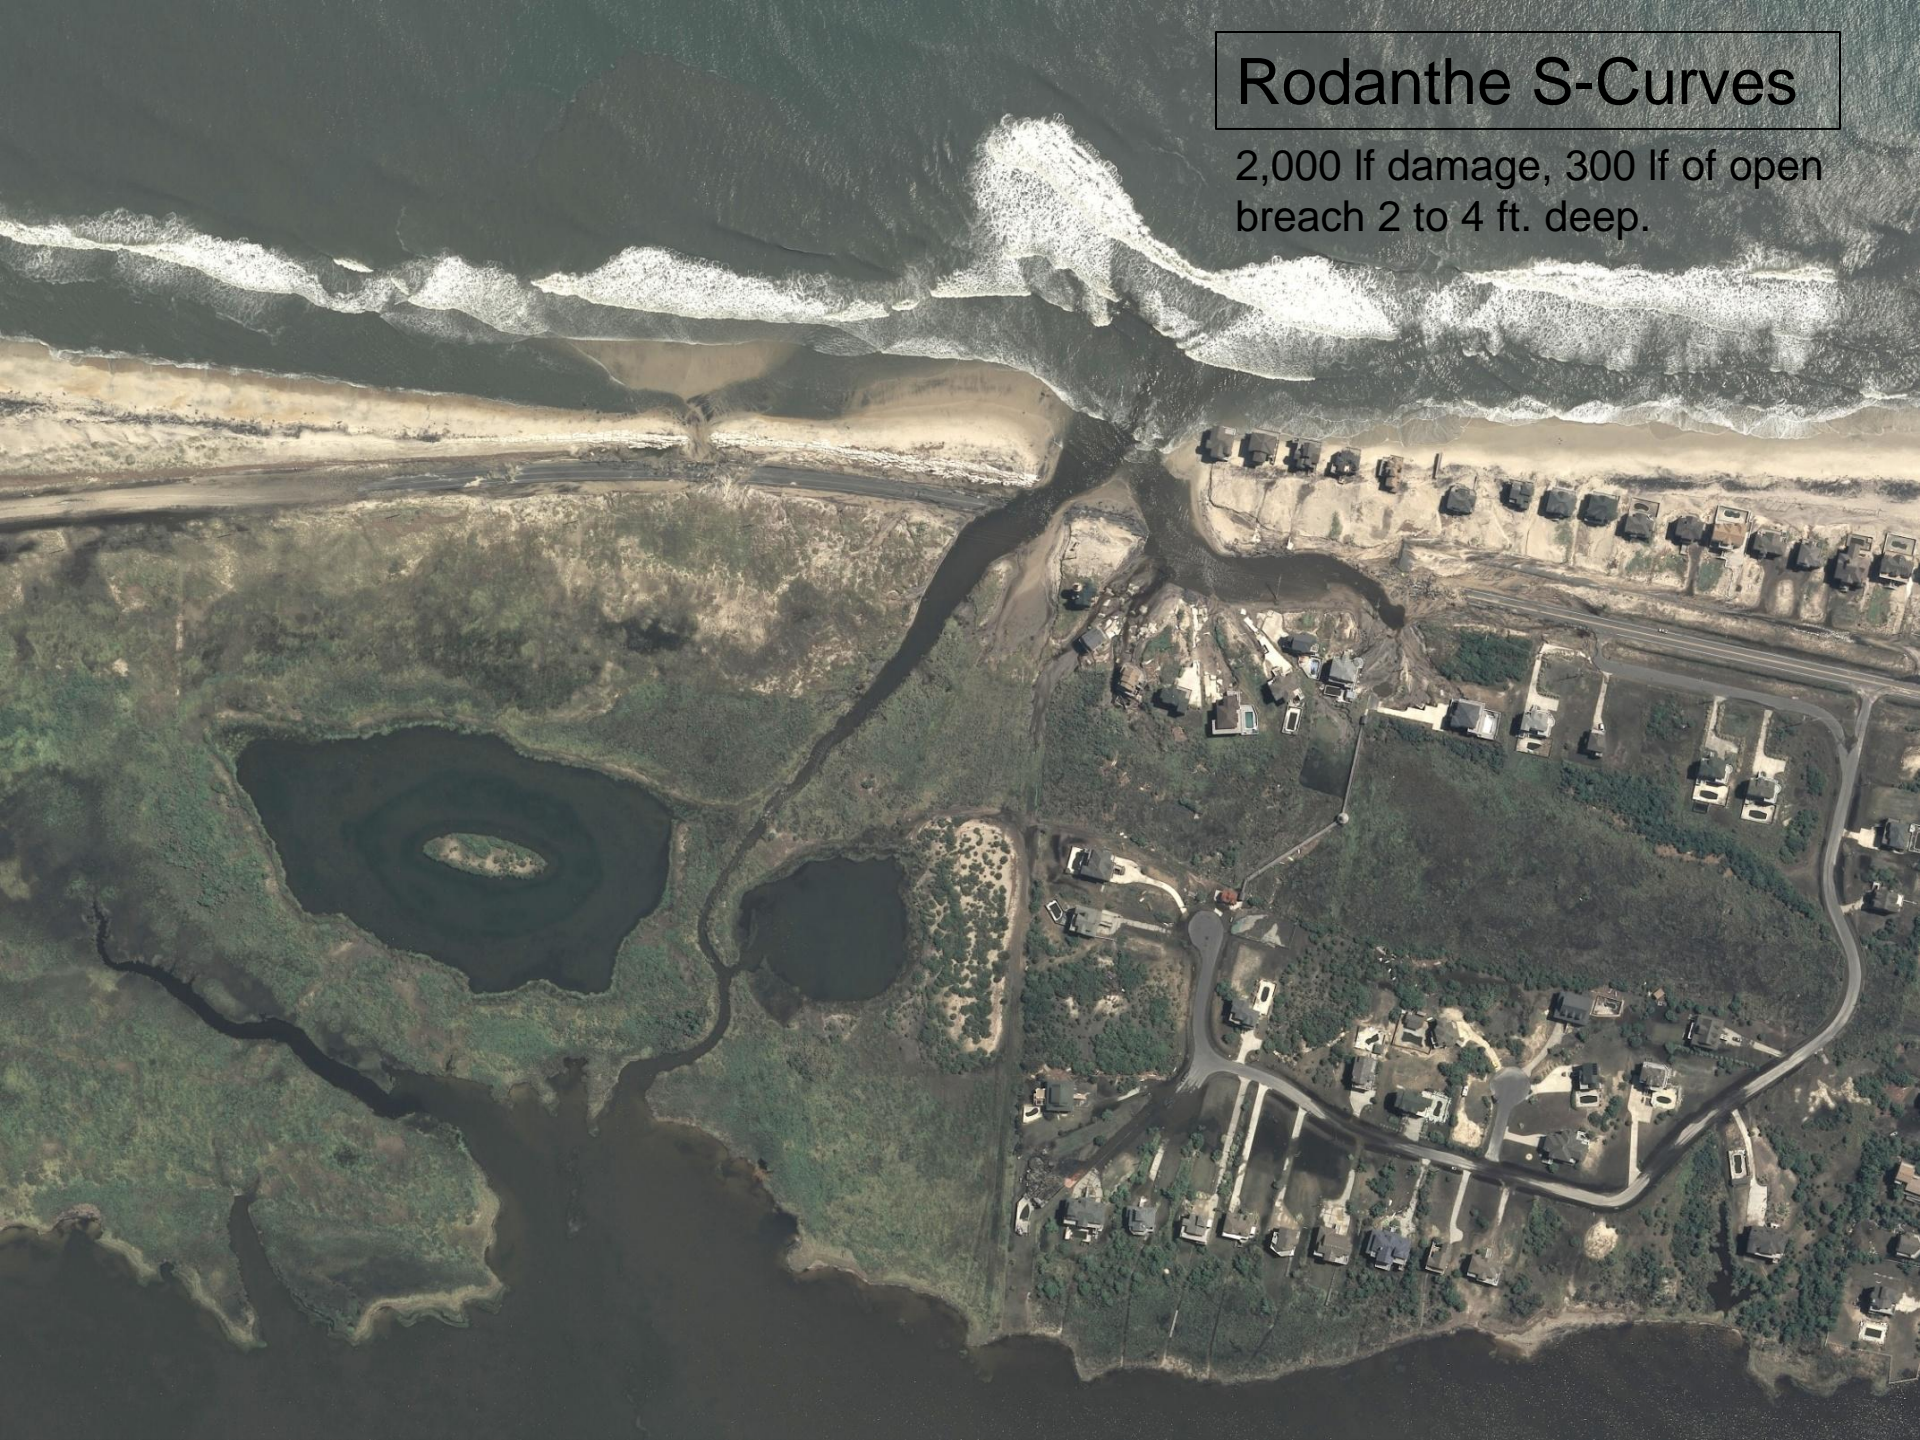
Rodanthe S-Curves

2,000 lf damage, 300 lf of open
breach 2 to 4 ft. deep.

An aerial photograph showing a coastal area with a large breach in the barrier. The ocean is at the top, with waves breaking onto a sandy beach. A dark, winding channel of water has cut through the barrier, separating a small island with some buildings from the mainland. A road runs horizontally across the middle of the image, with a bridge crossing the channel. The mainland is covered in green vegetation and has some smaller ponds or wetlands.

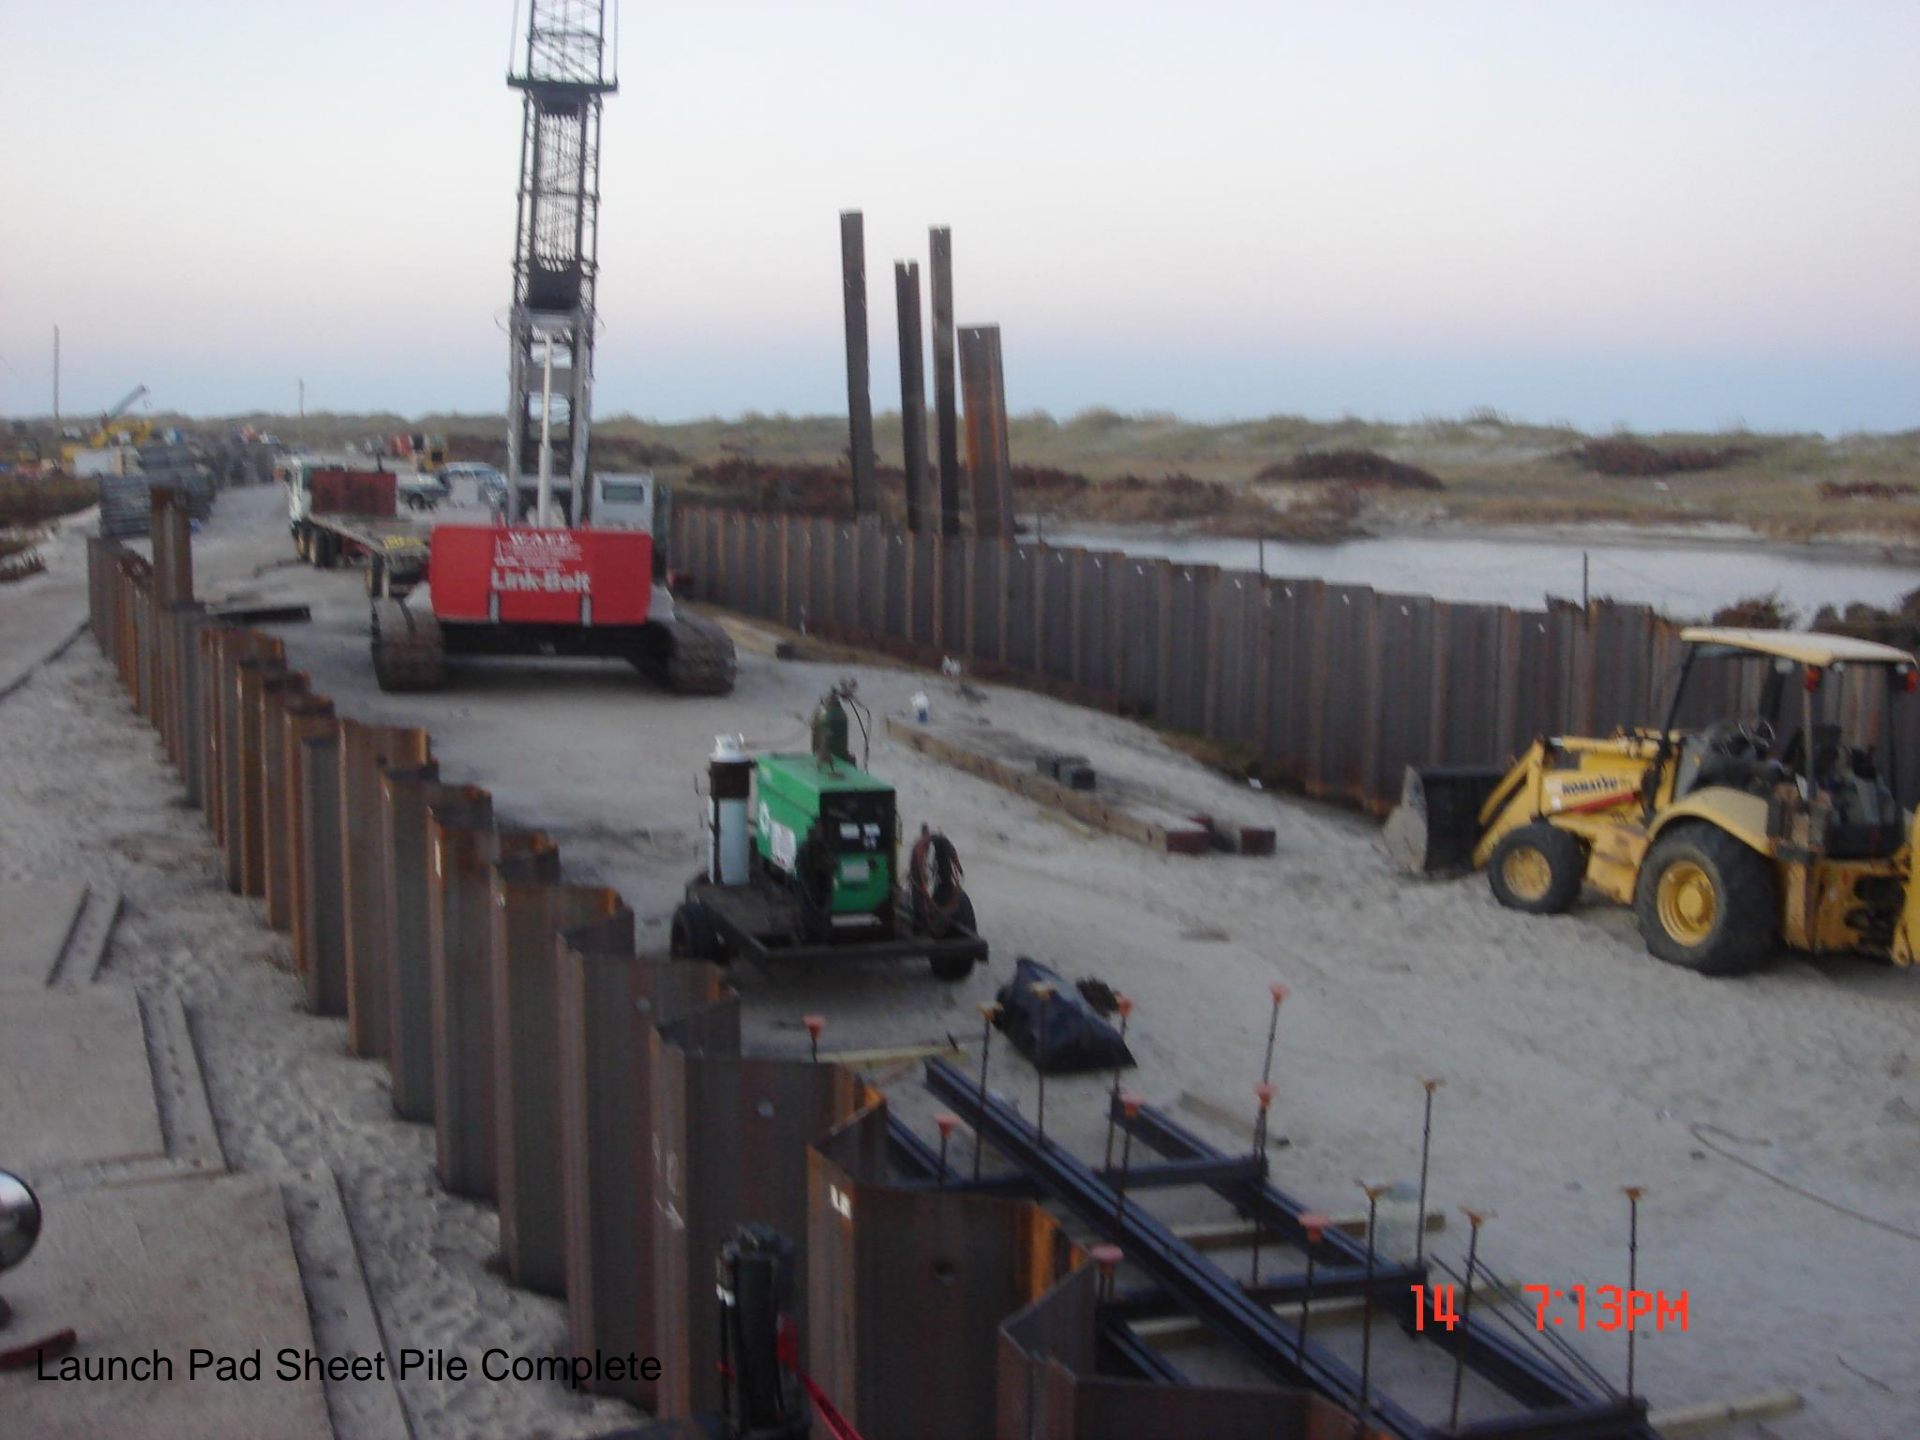
Launch Pad Sheet Pile Complete

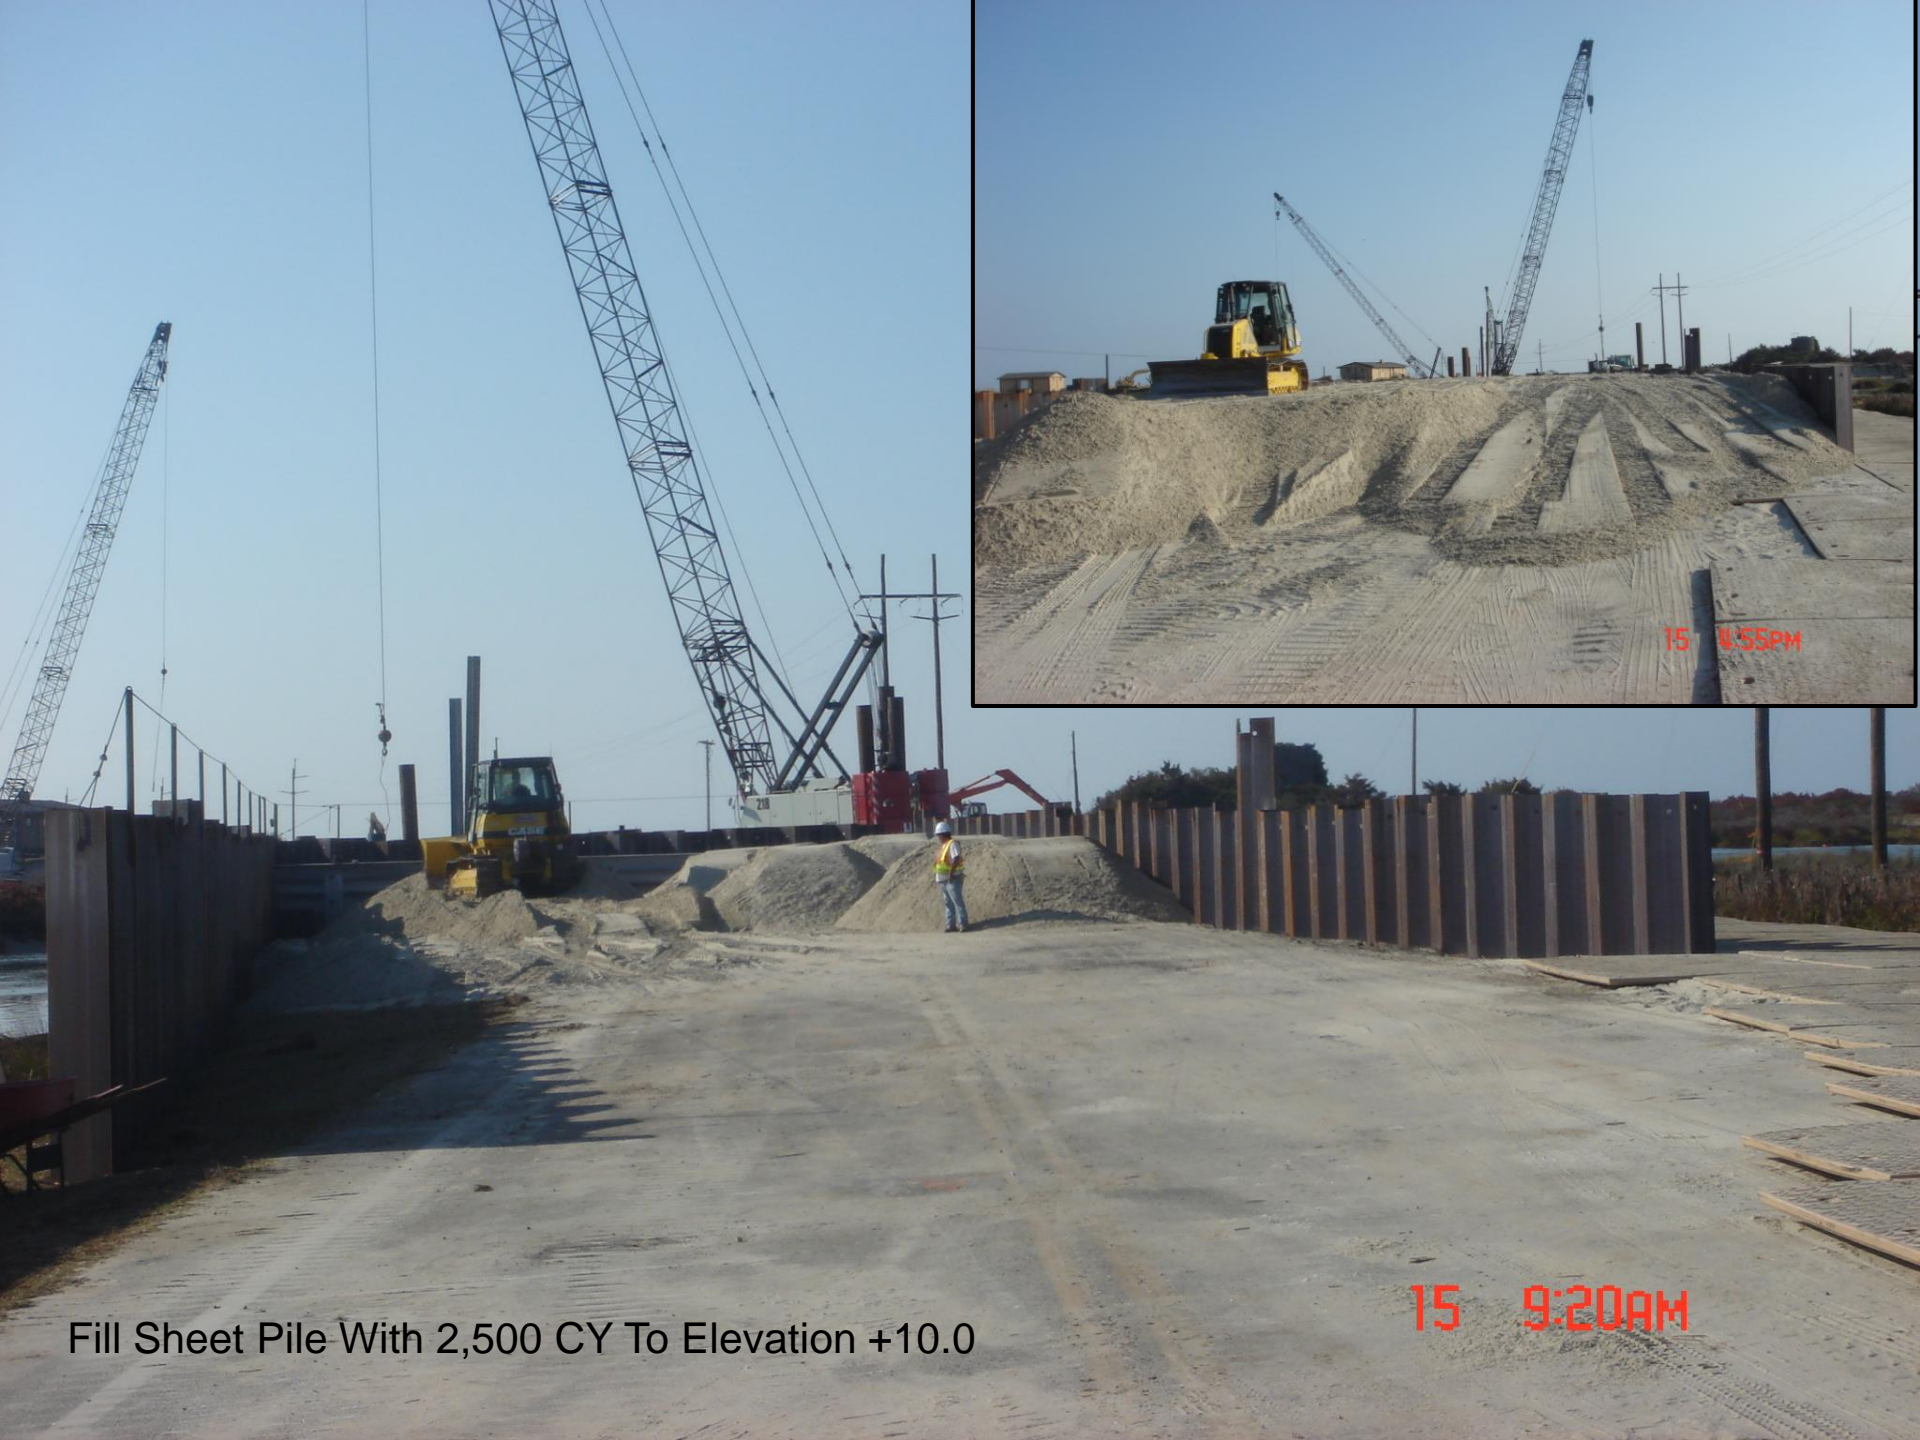
Fill Sheet Pile With 2,500 CY To Elevation +10.0

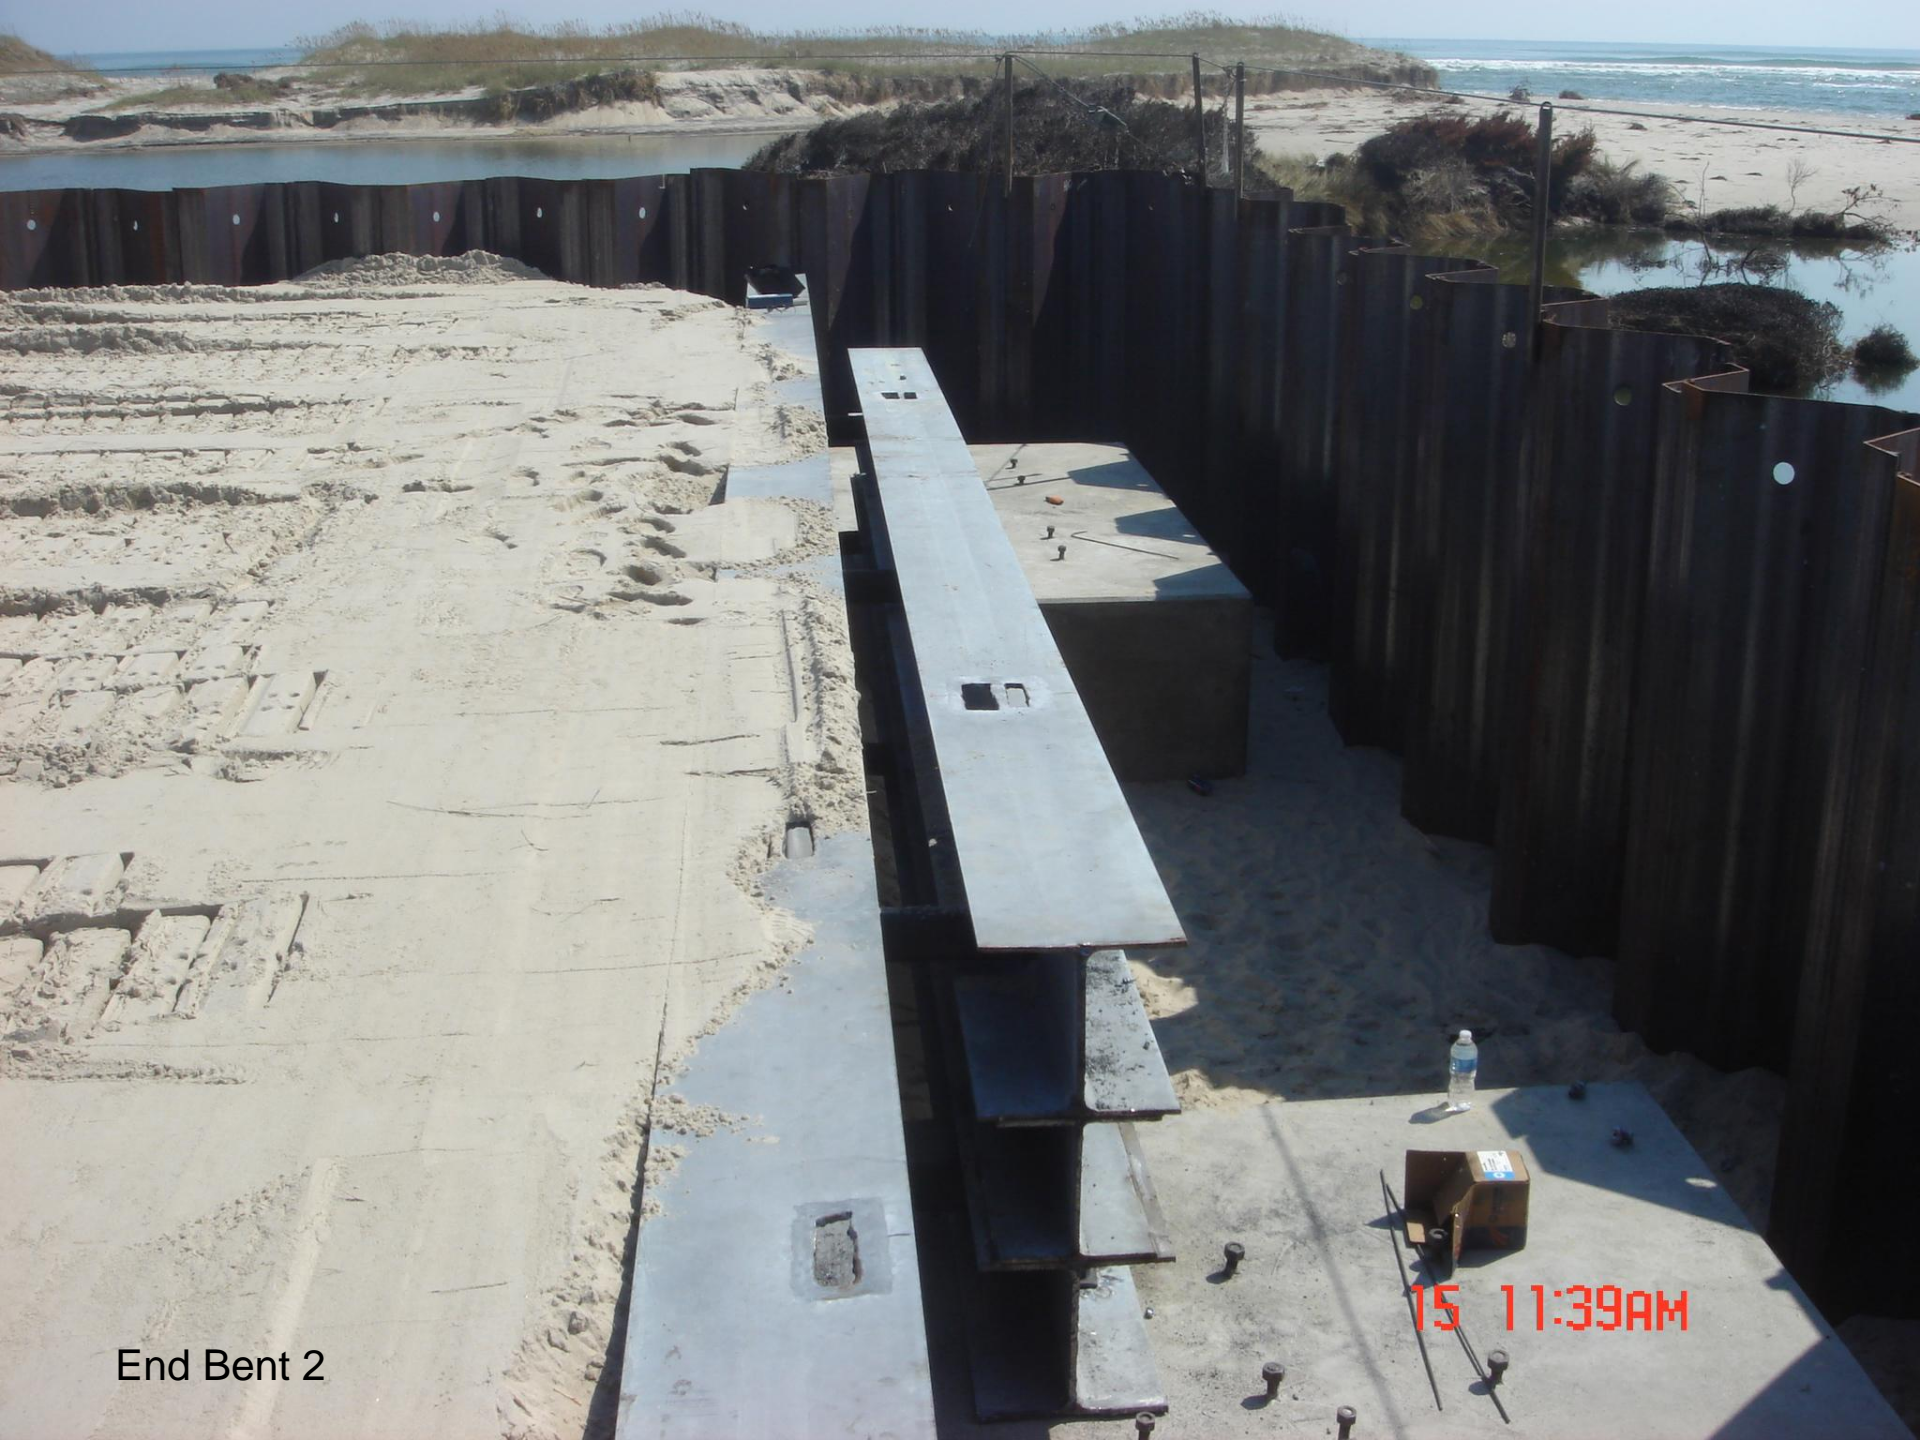
End Bent 2

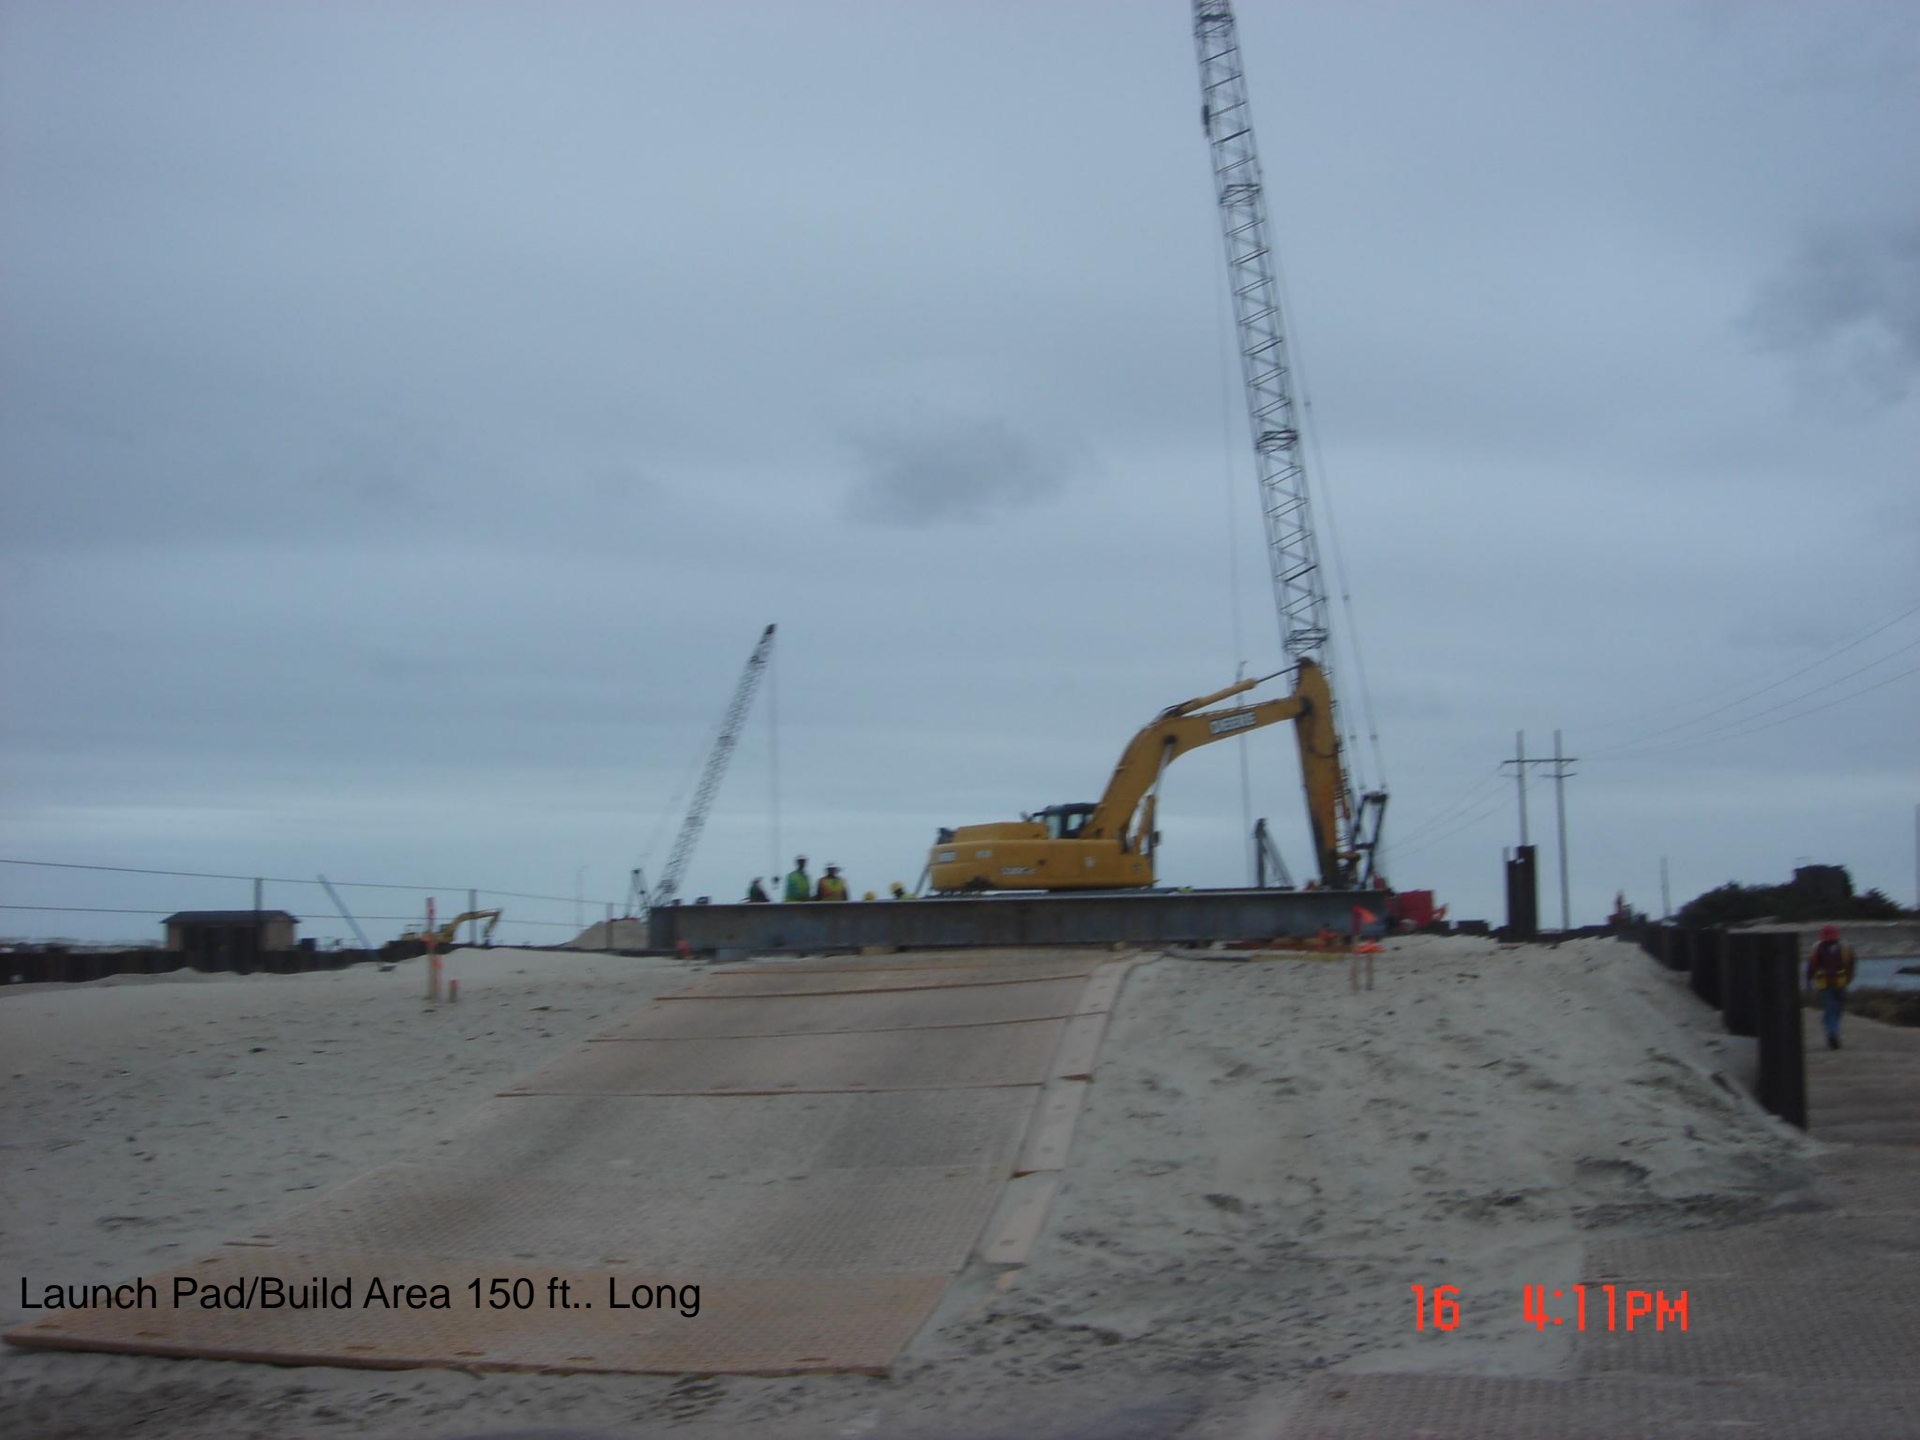
Launch Pad/Build Area 150 ft.. Long

- ❑ Set 400 pound temporary roller bearings on caps & launch pad.
- ❑ Alignment very critical due to launching method.

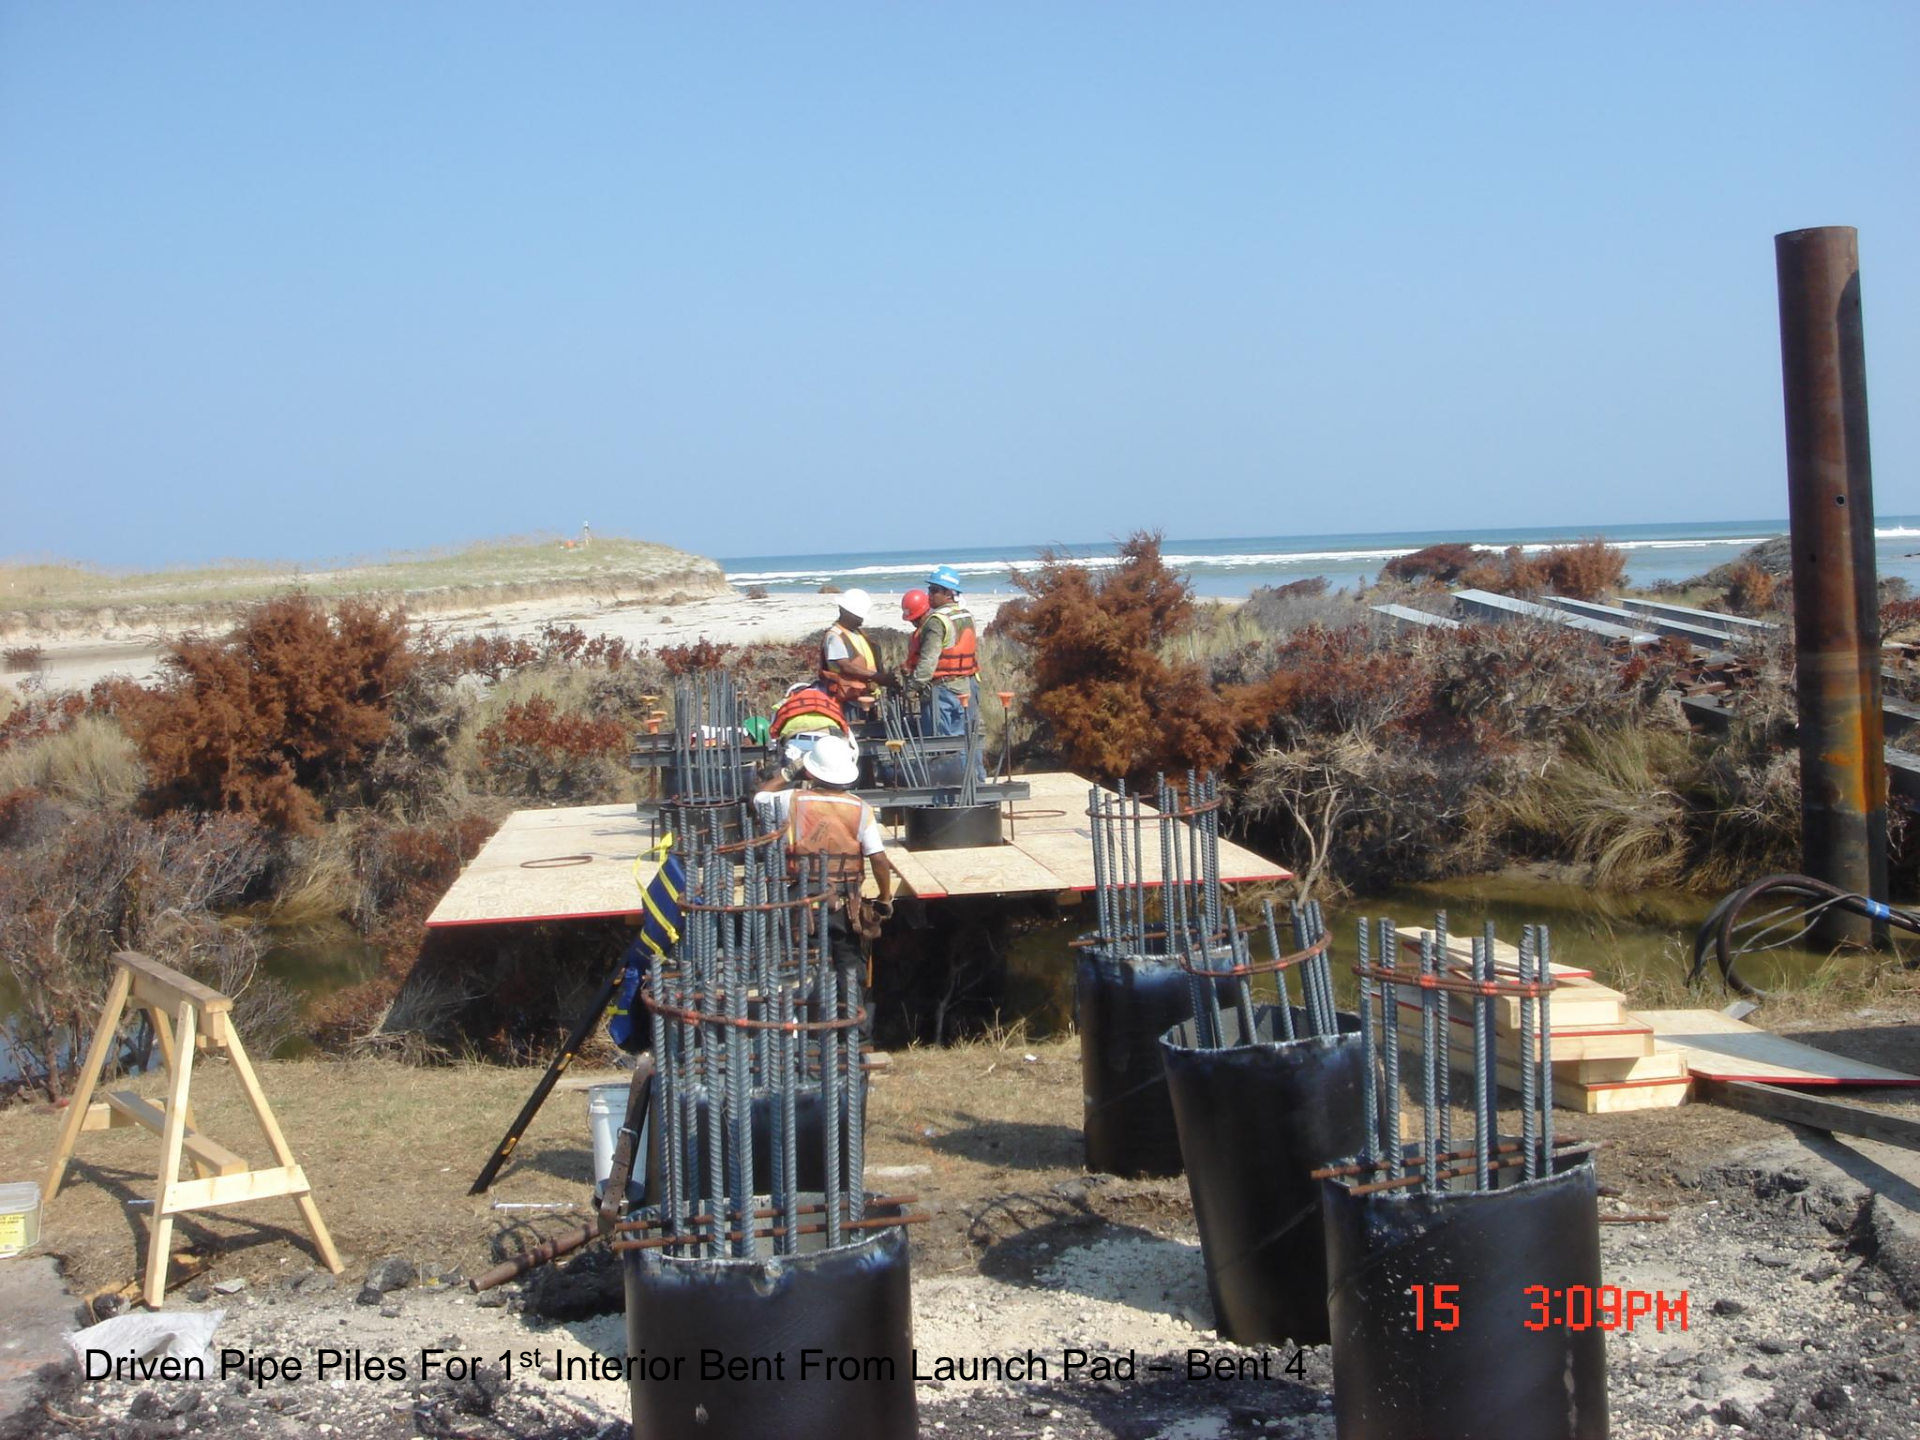
Driven Pipe Piles For 1st Interior Bent From Launch Pad – Bent 4

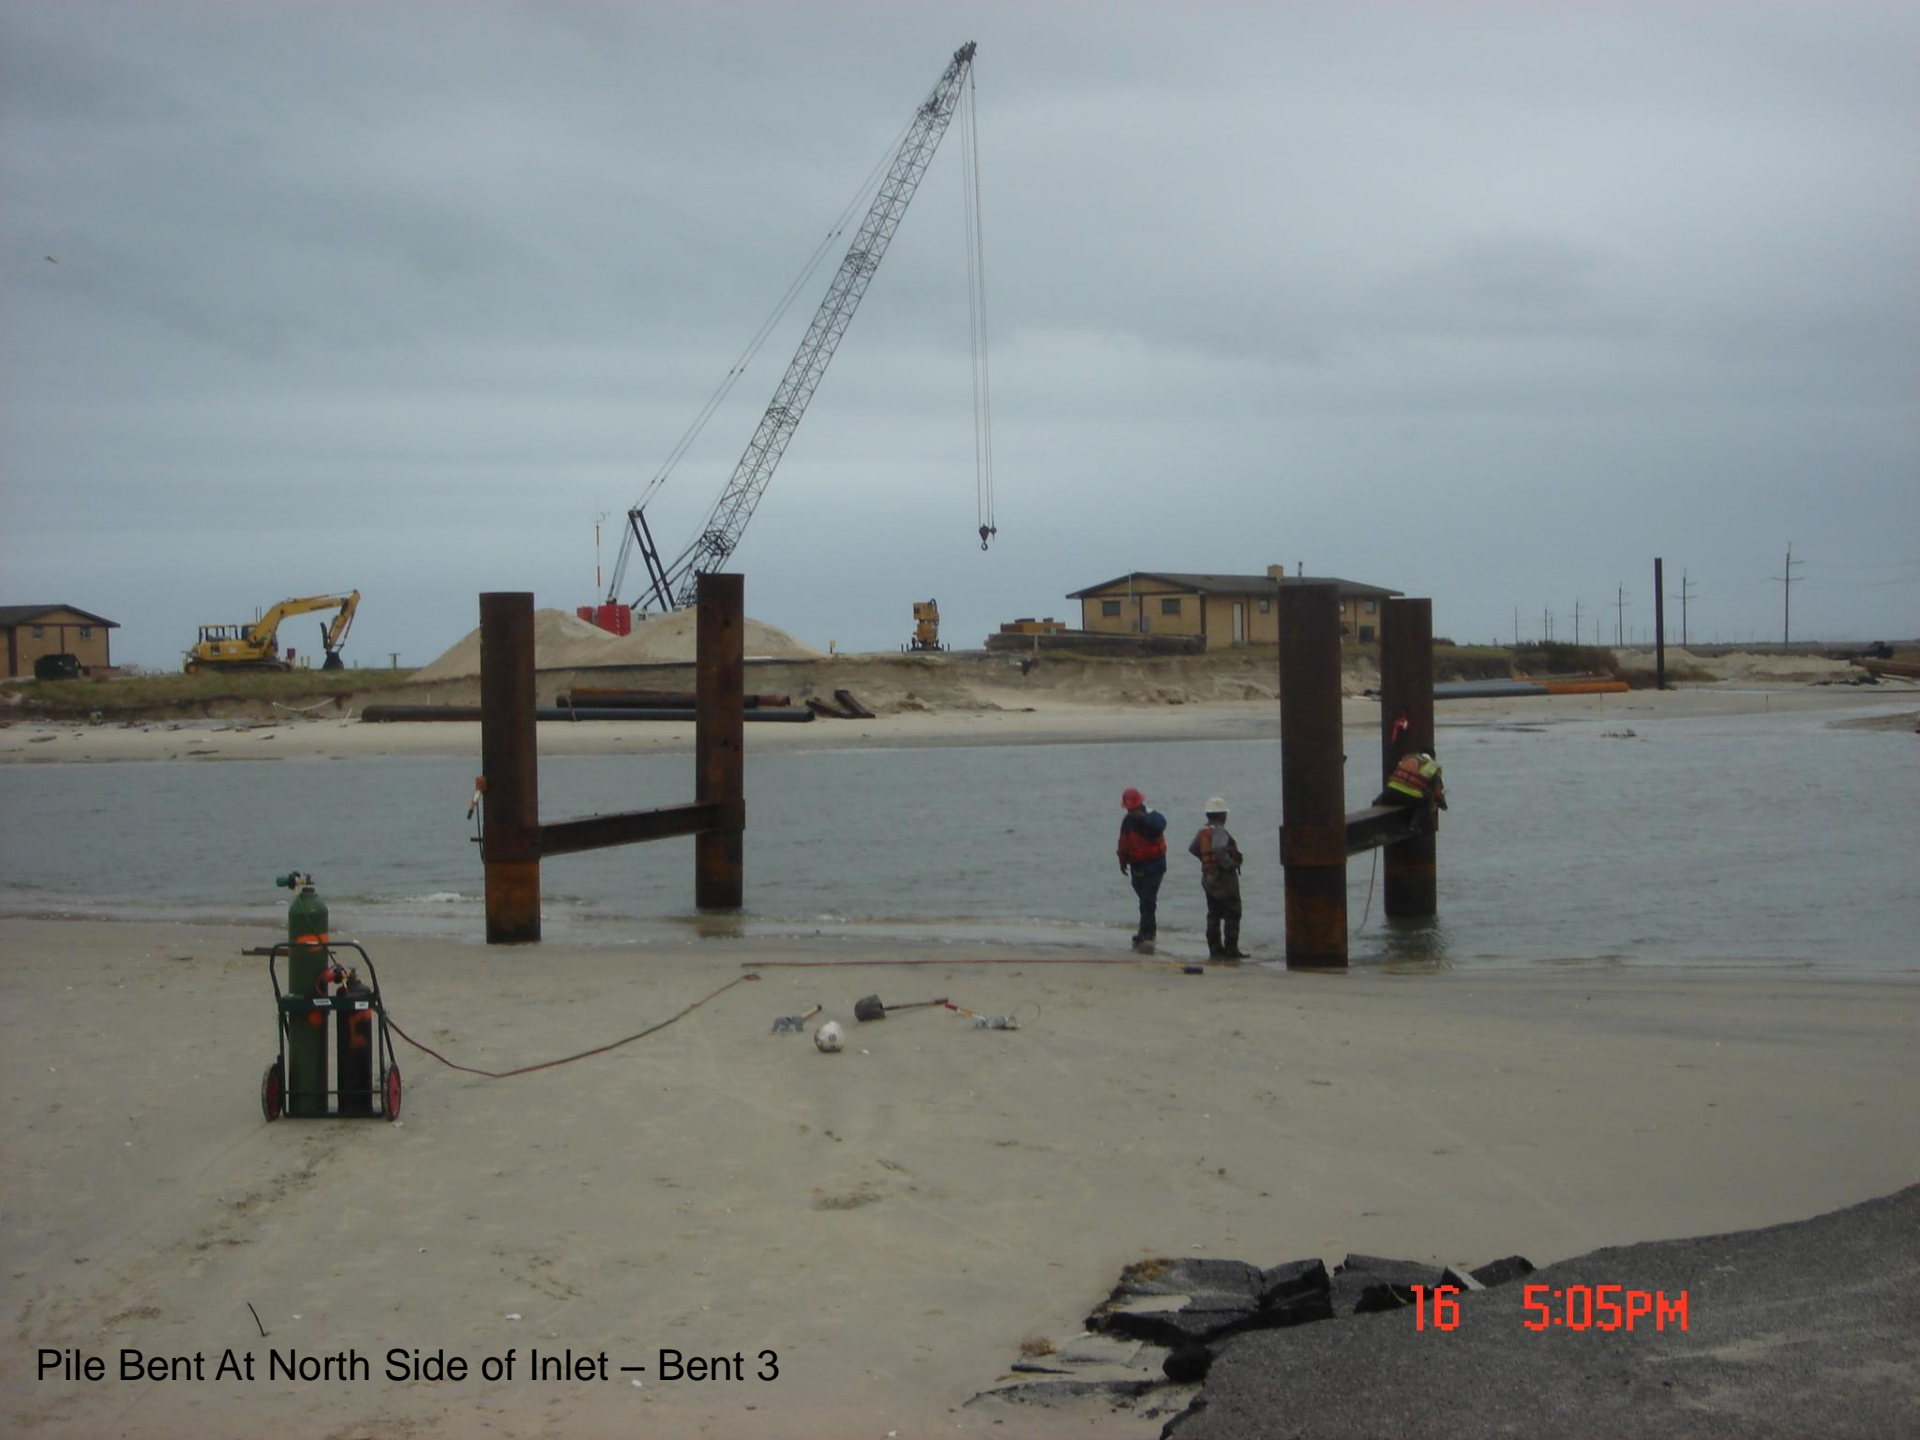
Pile Bent At North Side of Inlet – Bent 3

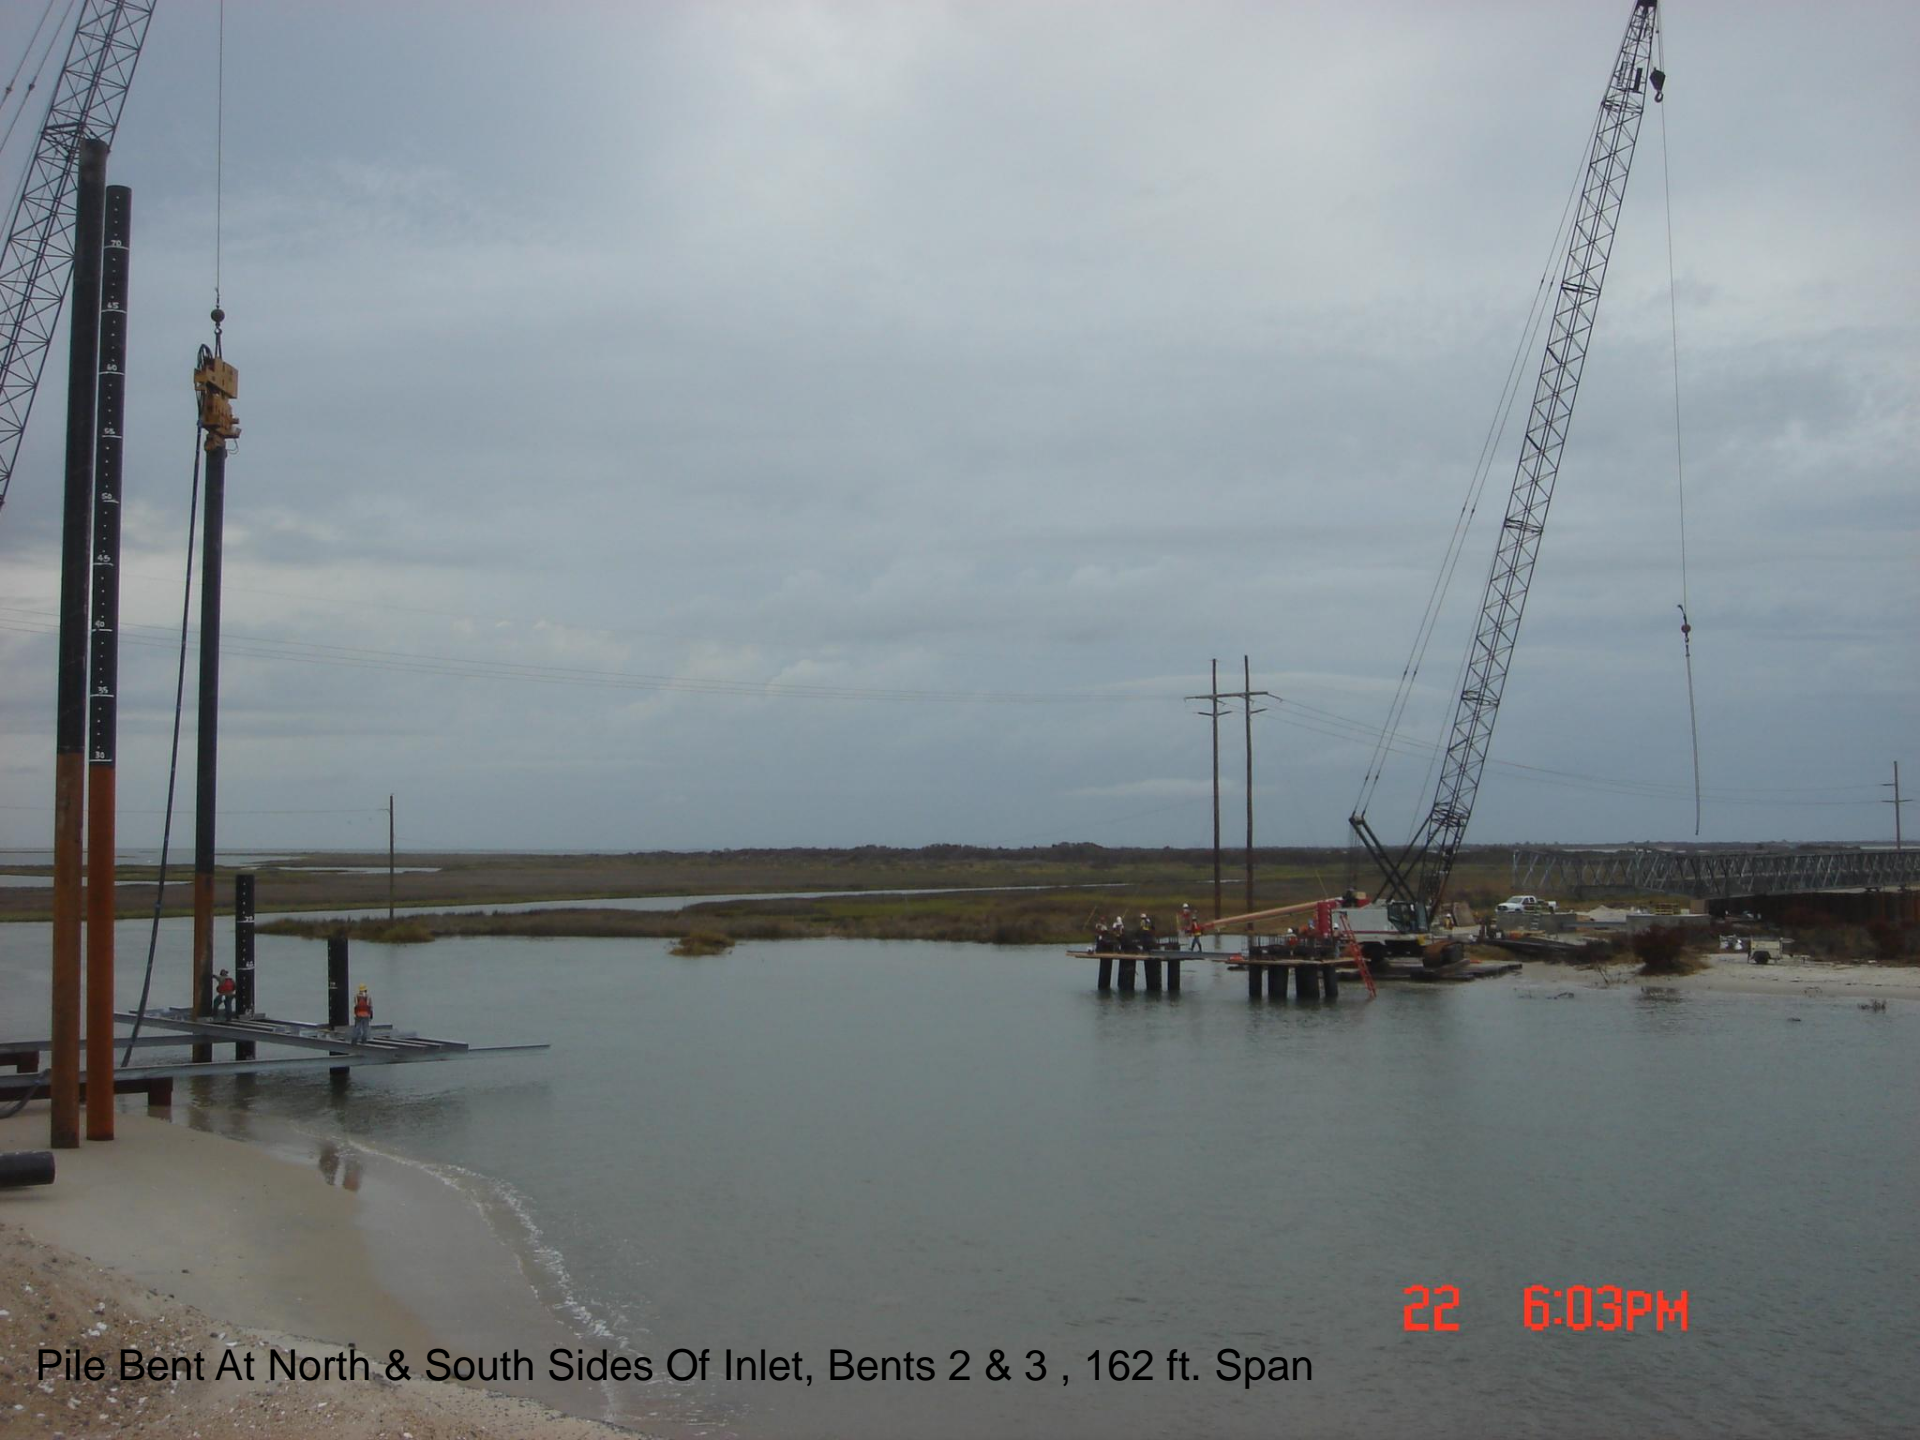
Pile Bent At North & South Sides Of Inlet, Bents 2 & 3 , 162 ft. Span
