NCDOT NC 12 Response Post Hurricane Irene Aug. 28 – Oct. 10, 2011

NC 12 Damage Assessment from Hurricane Irene, Aug. 27, 2011

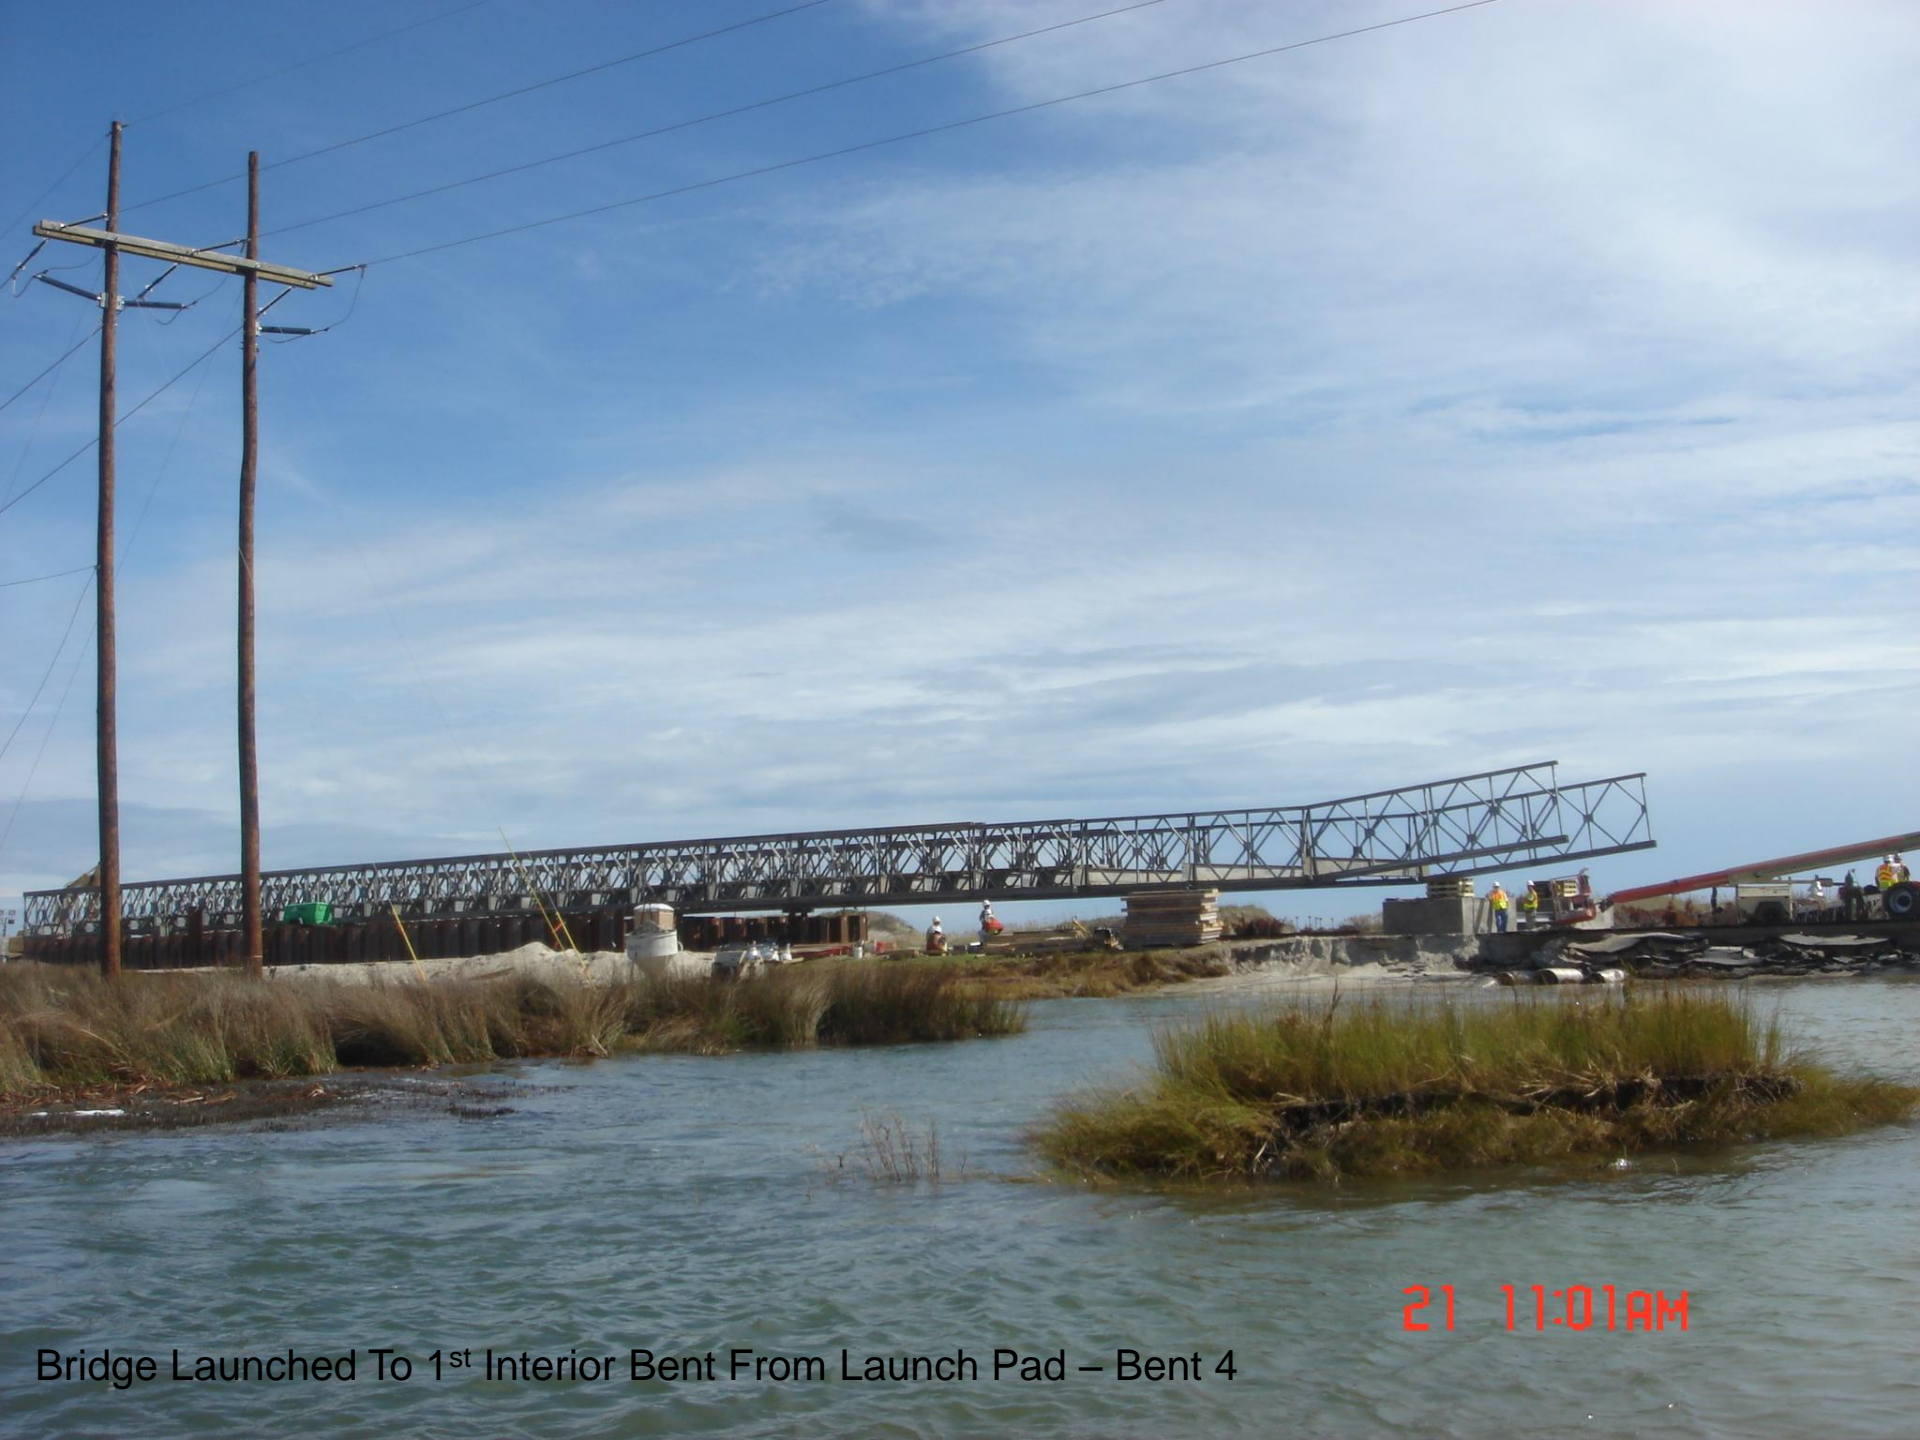
Bridge Launched To 1st Interior Bent From Launch Pad – Bent 4

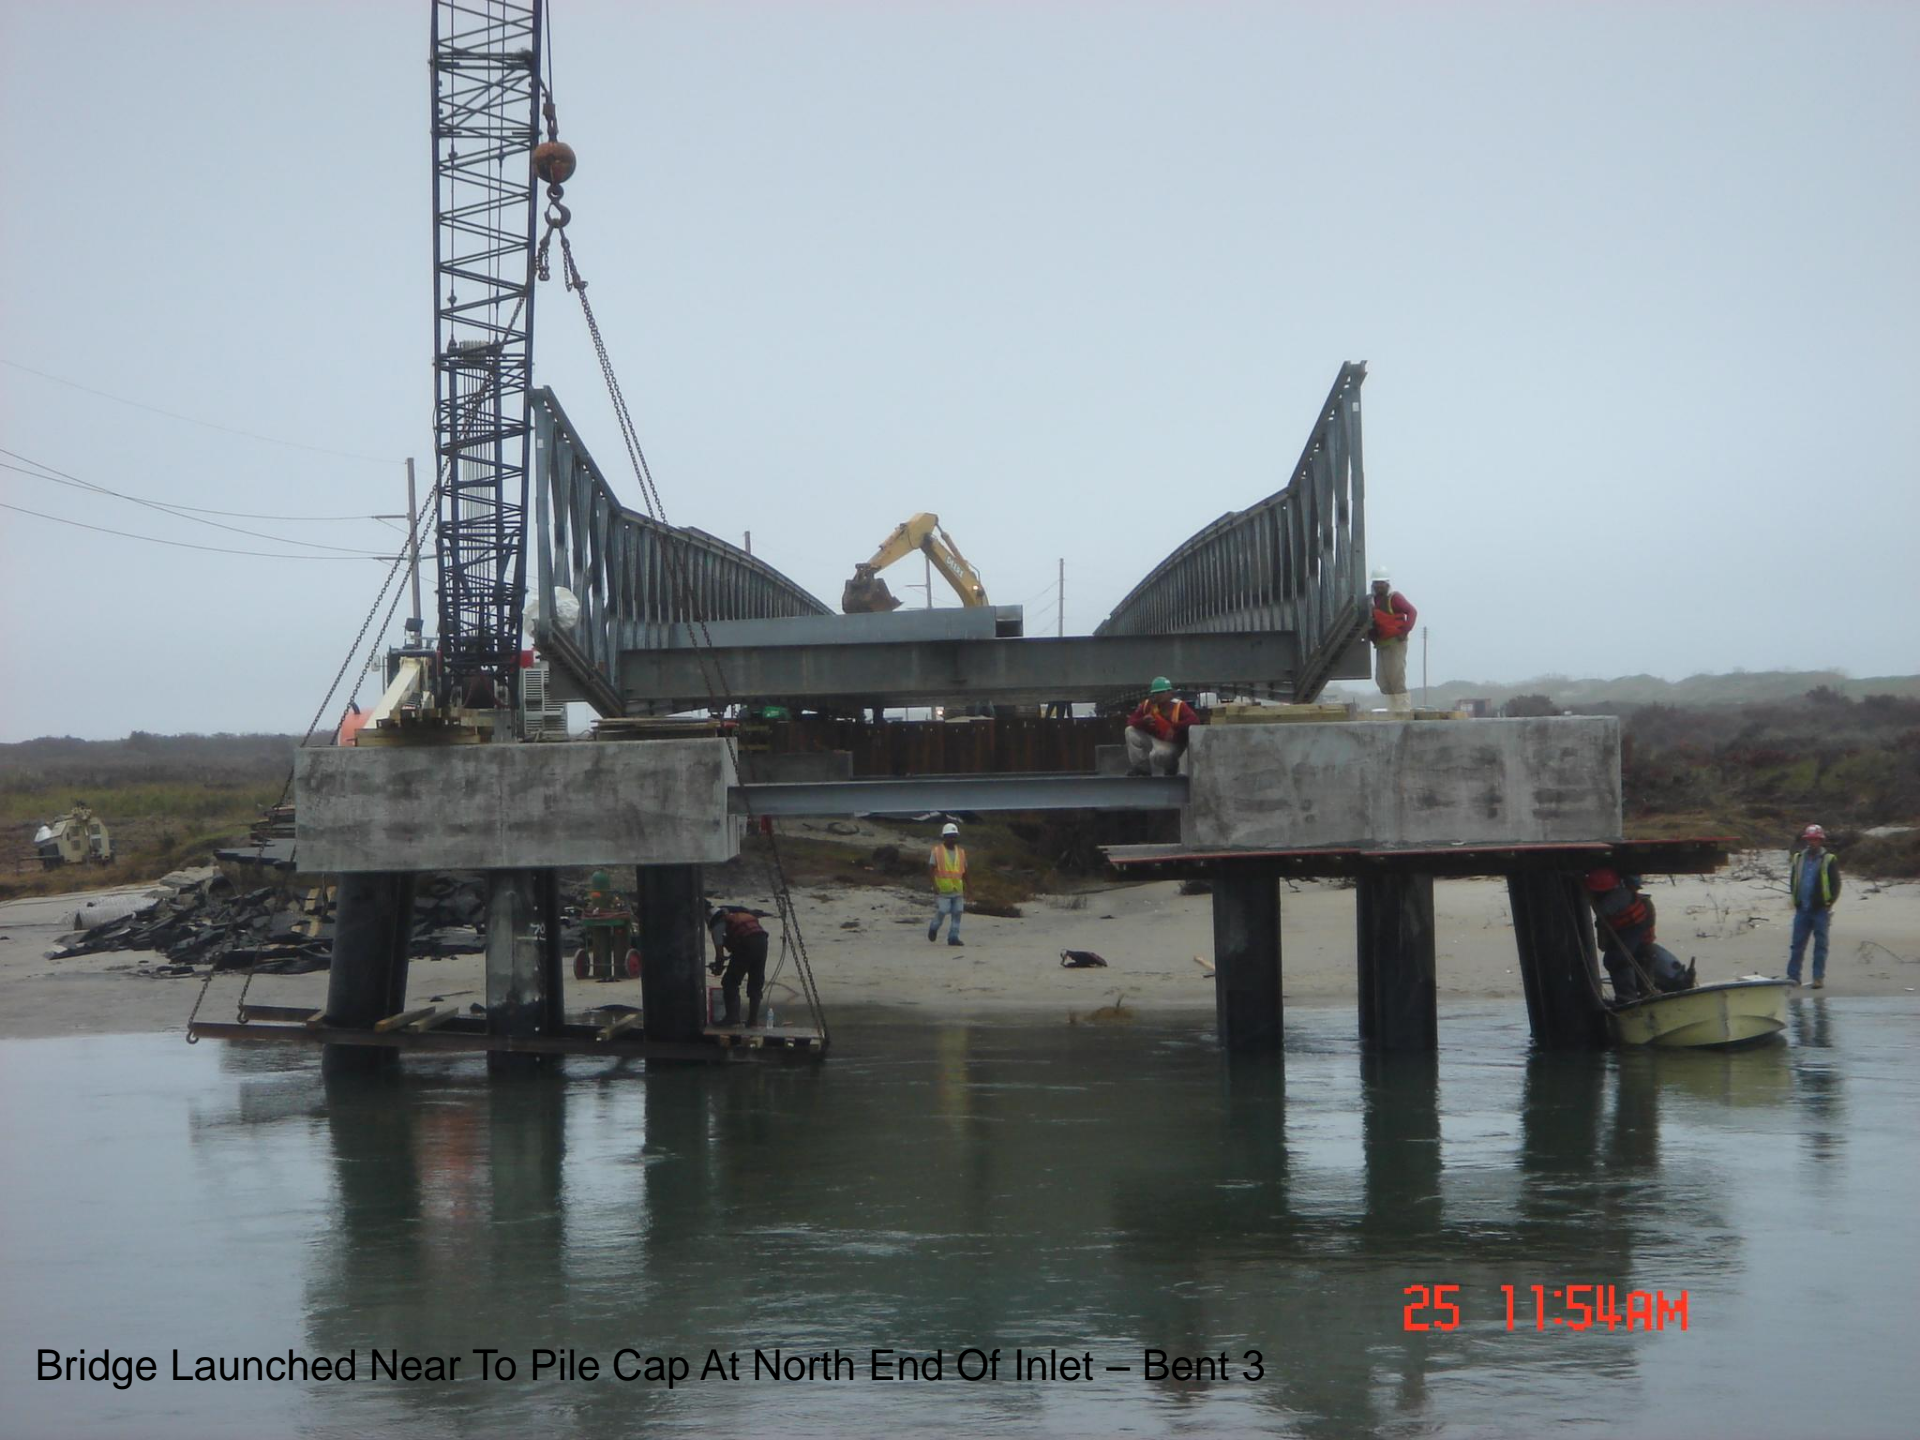
Bridge Launched Near To Pile Cap At North End Of Inlet – Bent 3

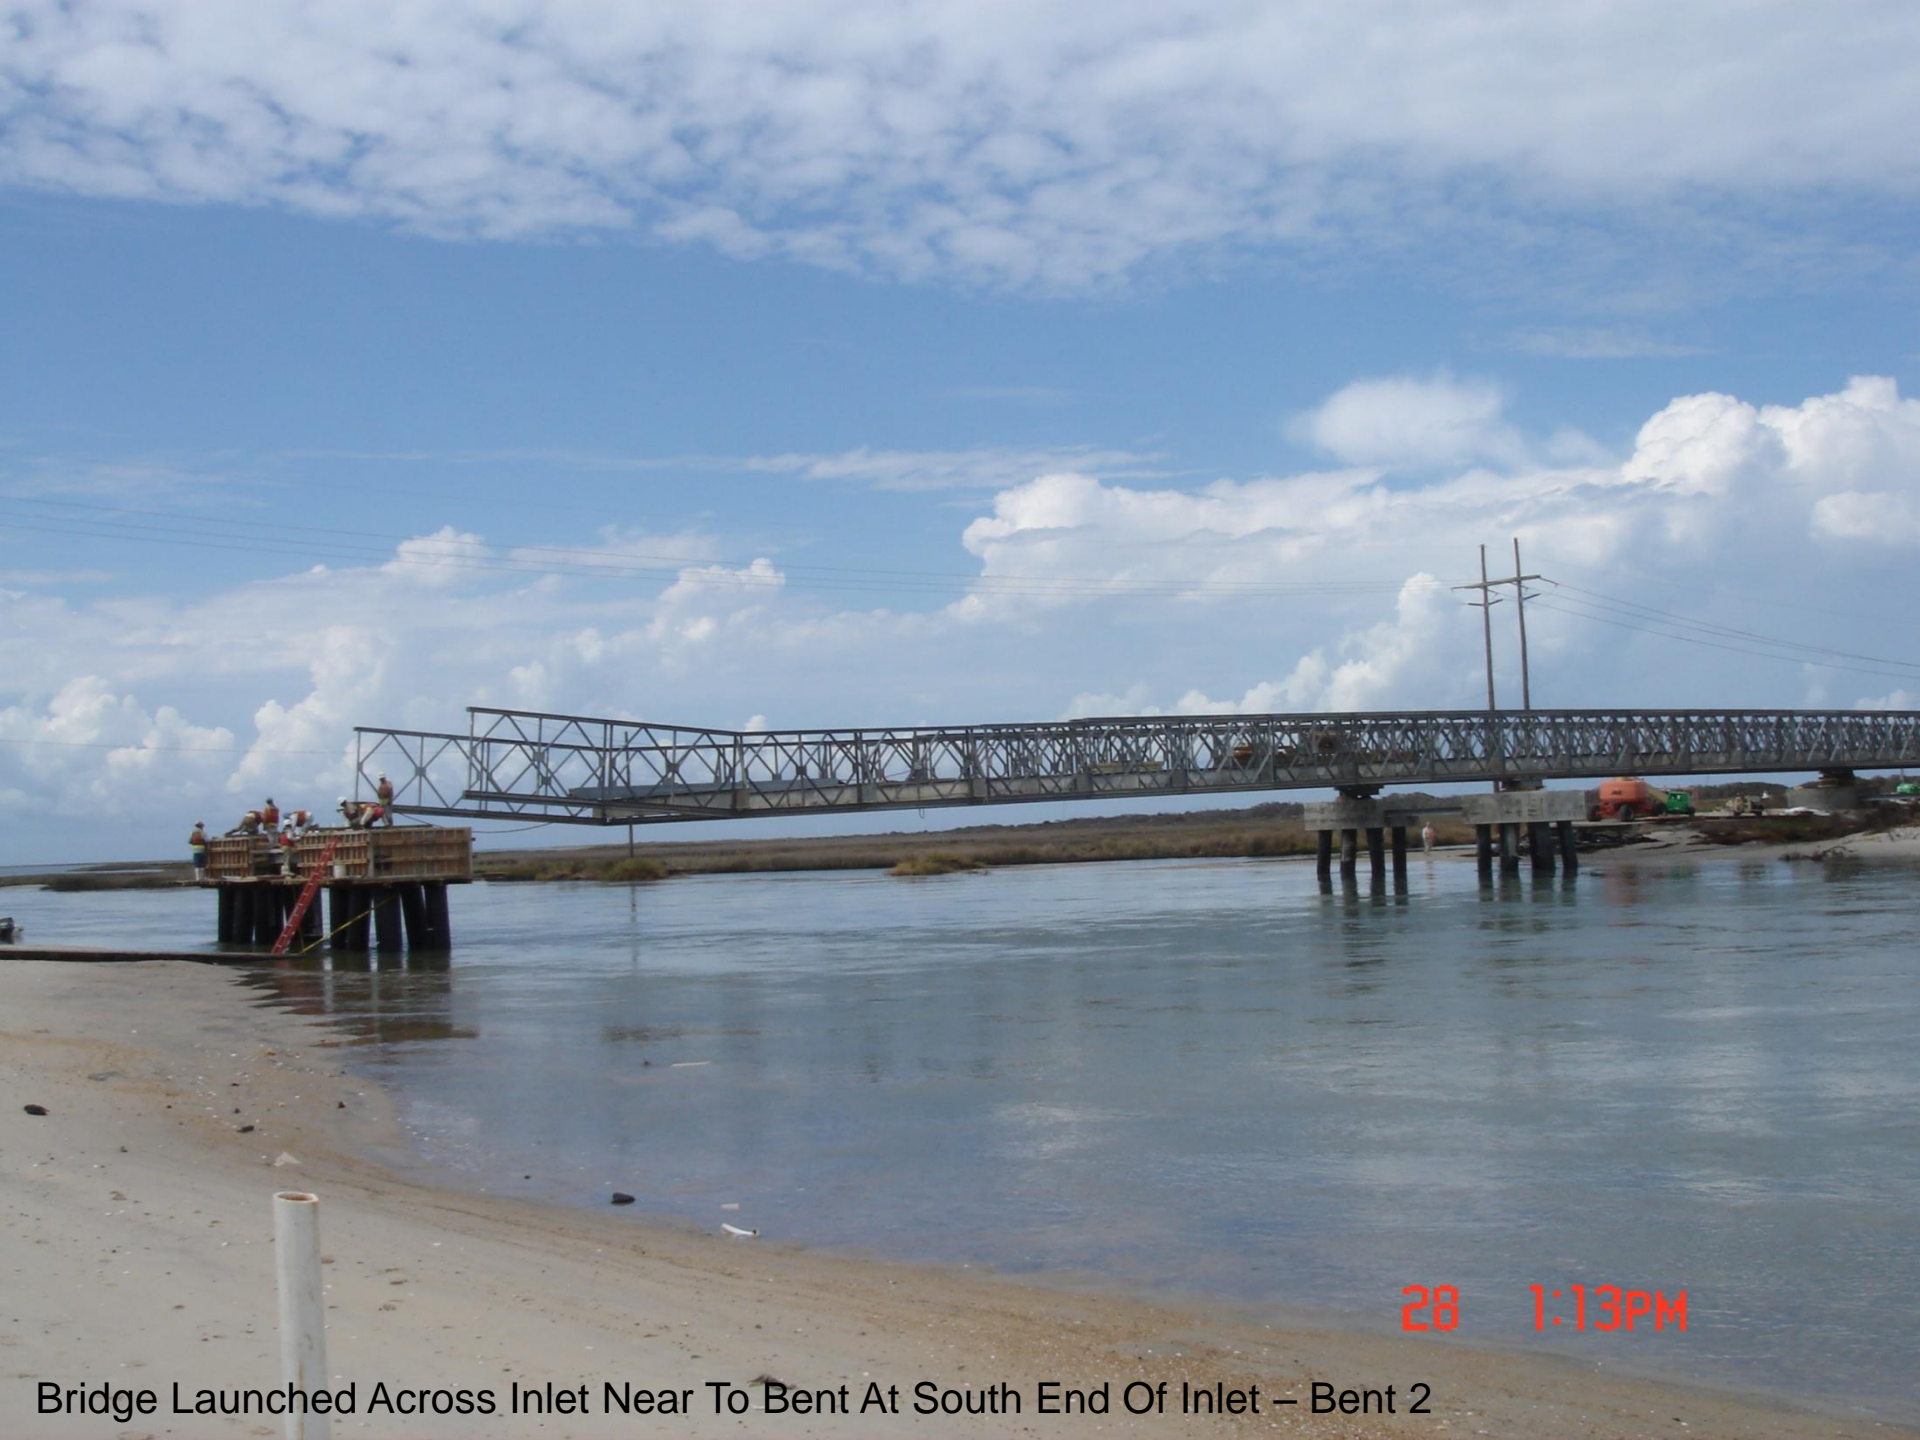
Bridge Launched Across Inlet Near To Bent At South End Of Inlet – Bent 2

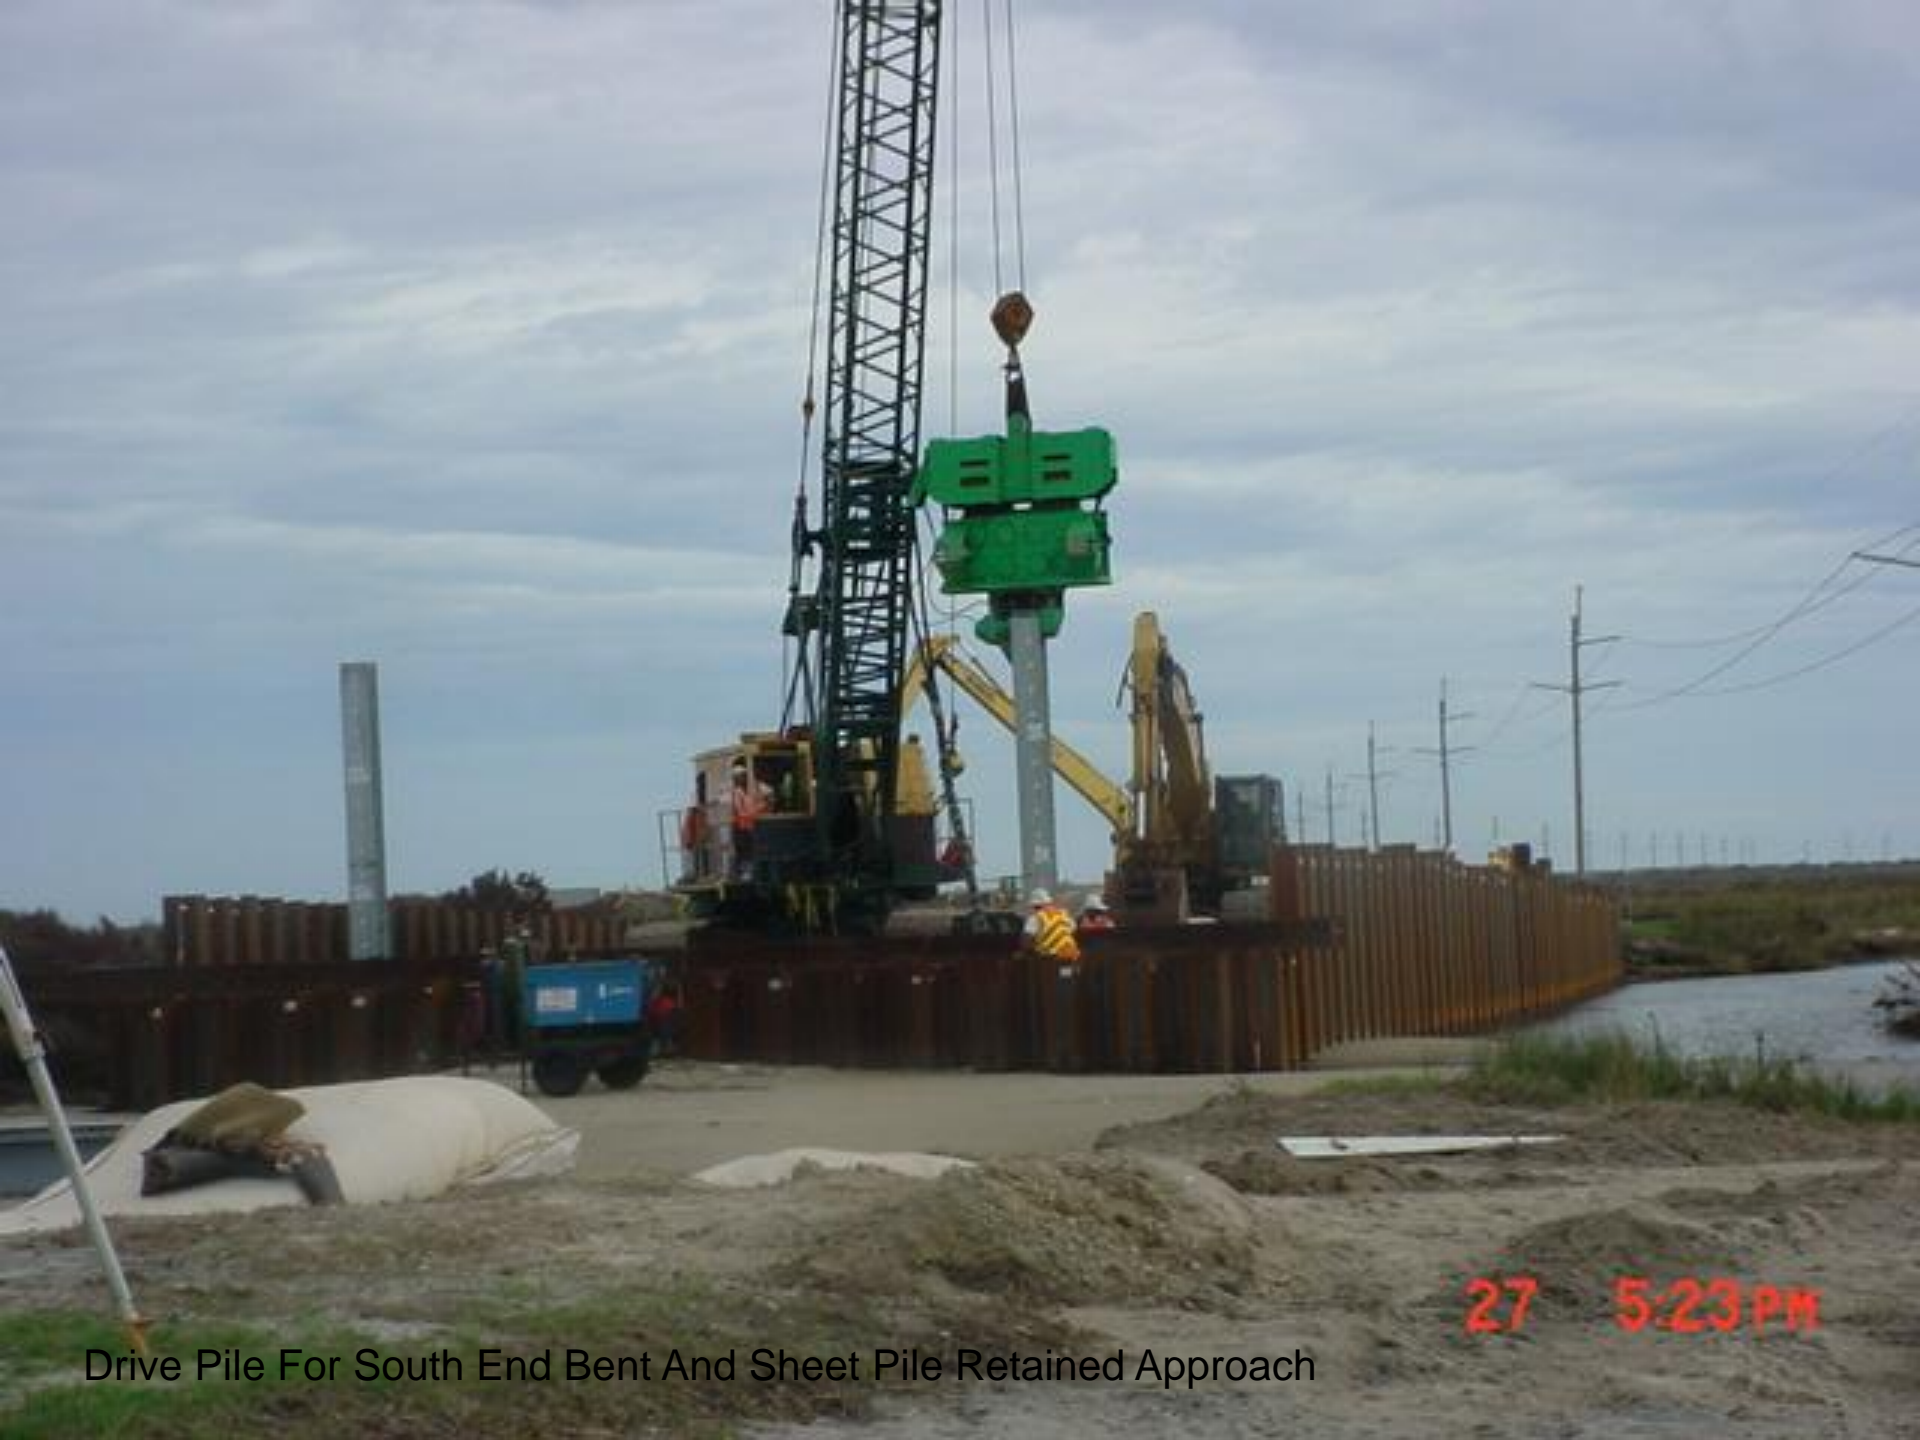
Drive Pile For South End Bent And Sheet Pile Retained Approach

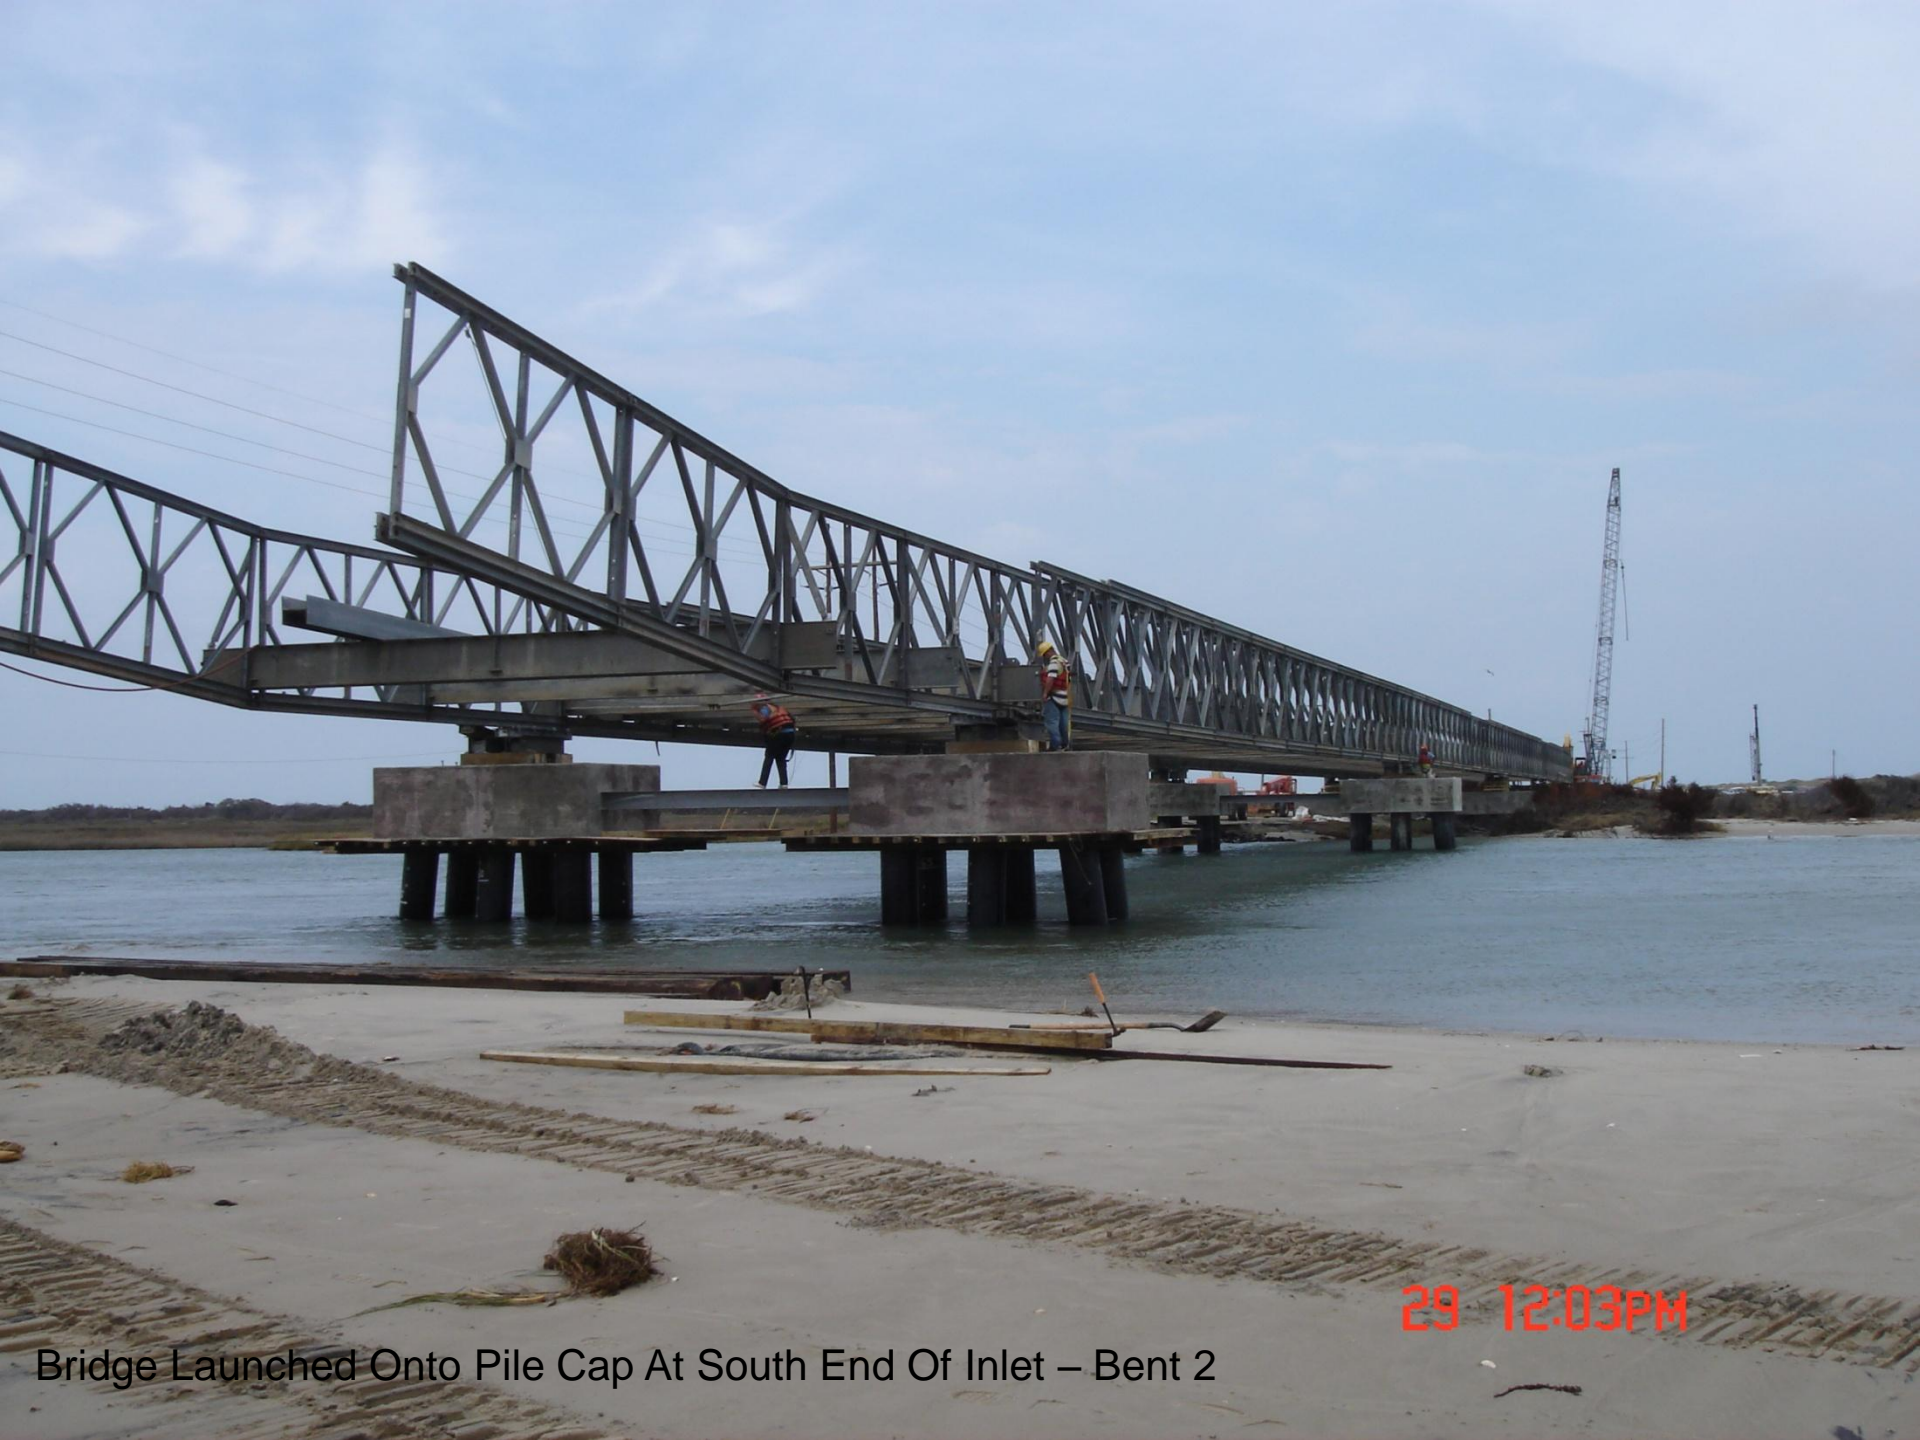
Bridge Launched Onto Pile Cap At South End Of Inlet – Bent 2

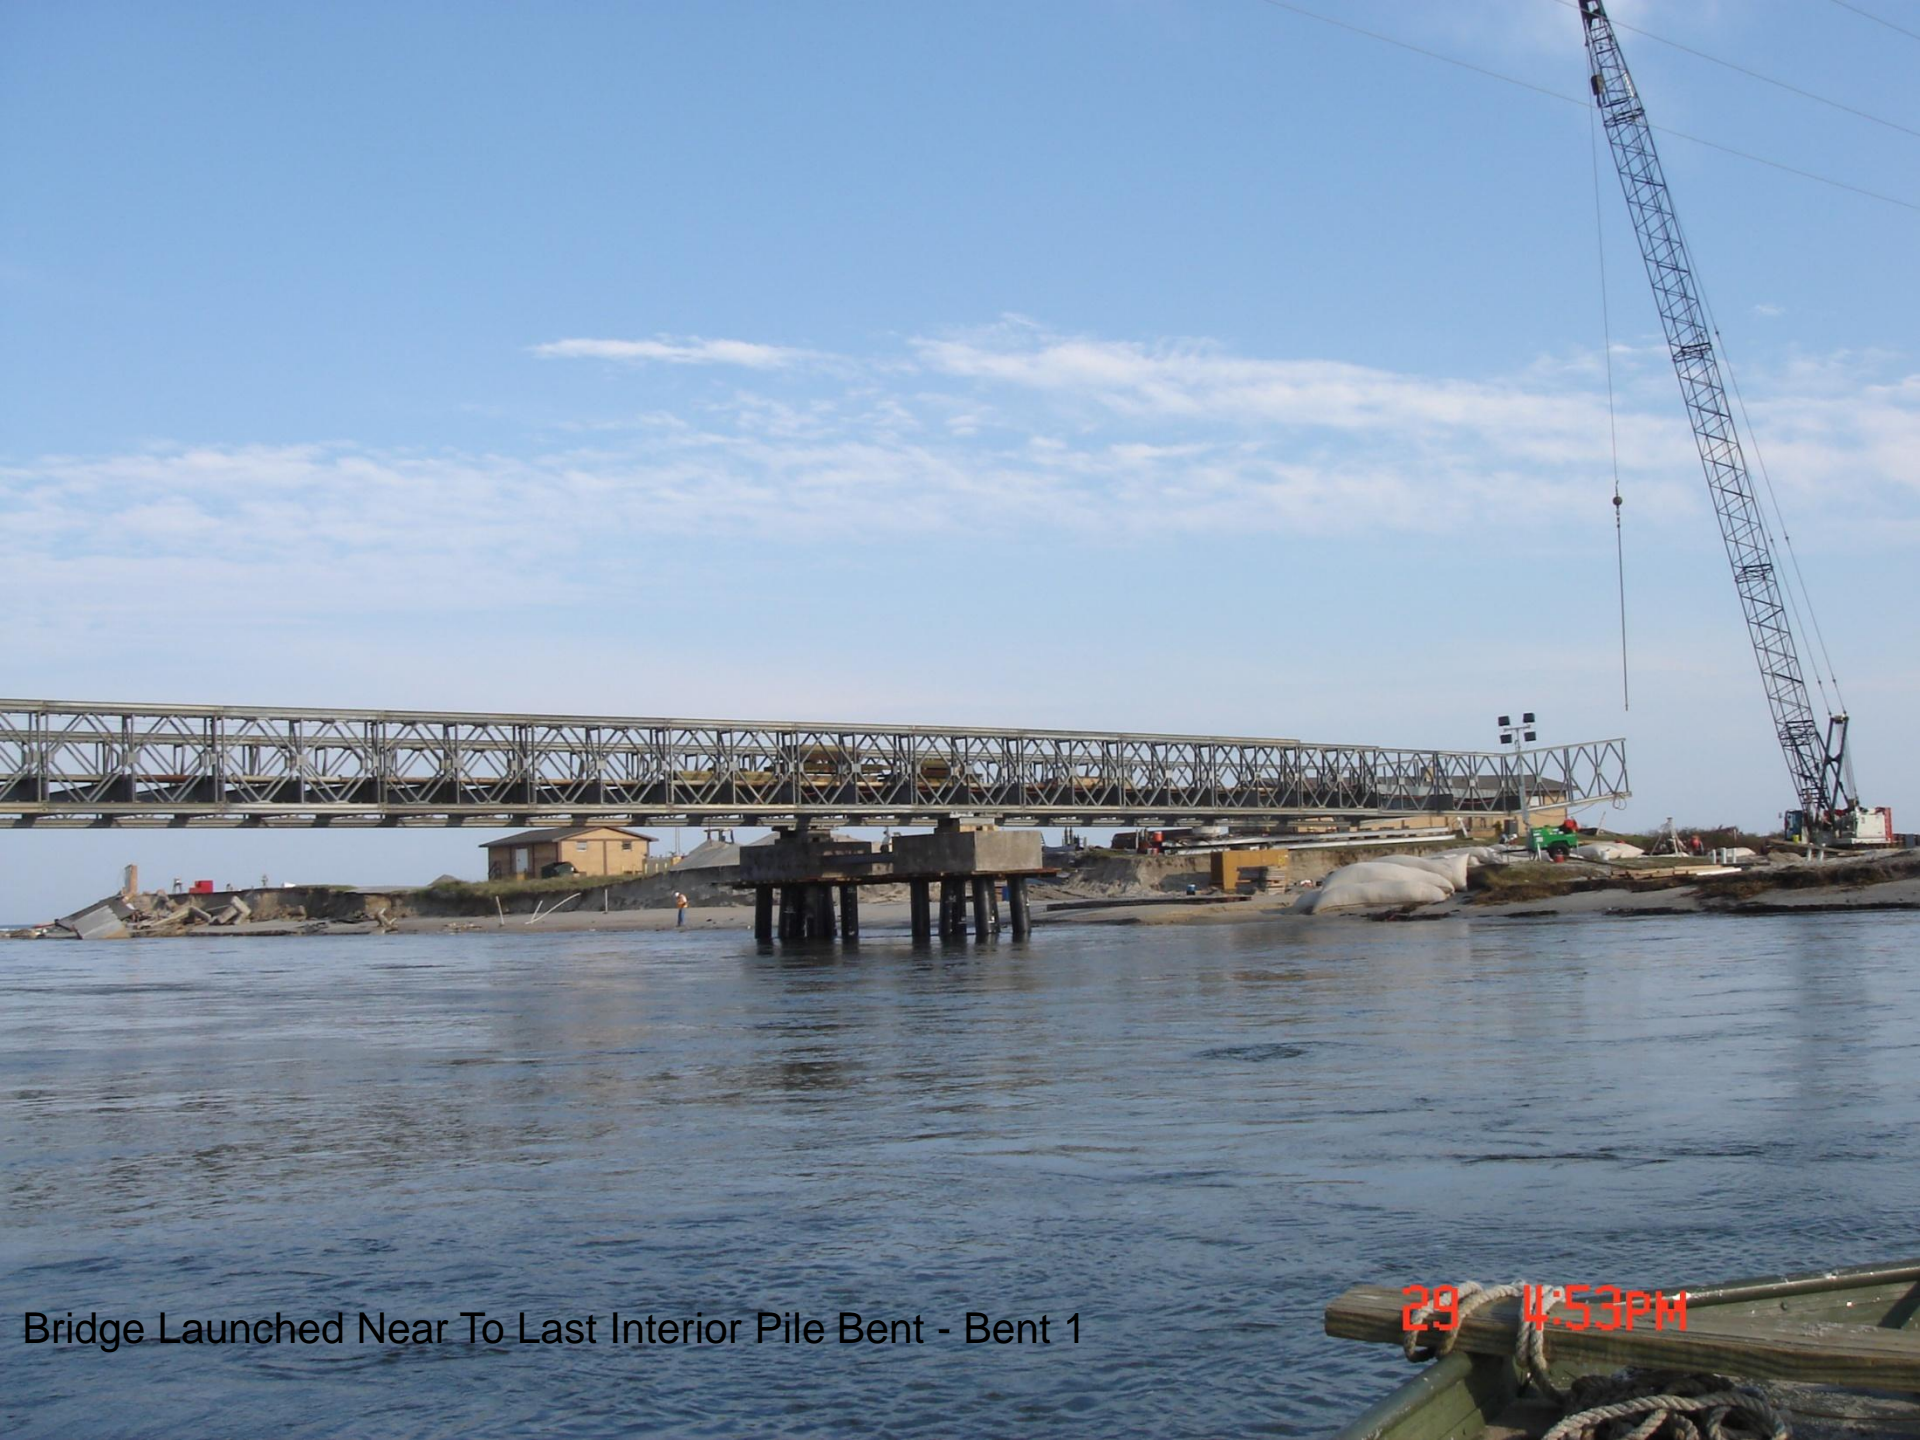
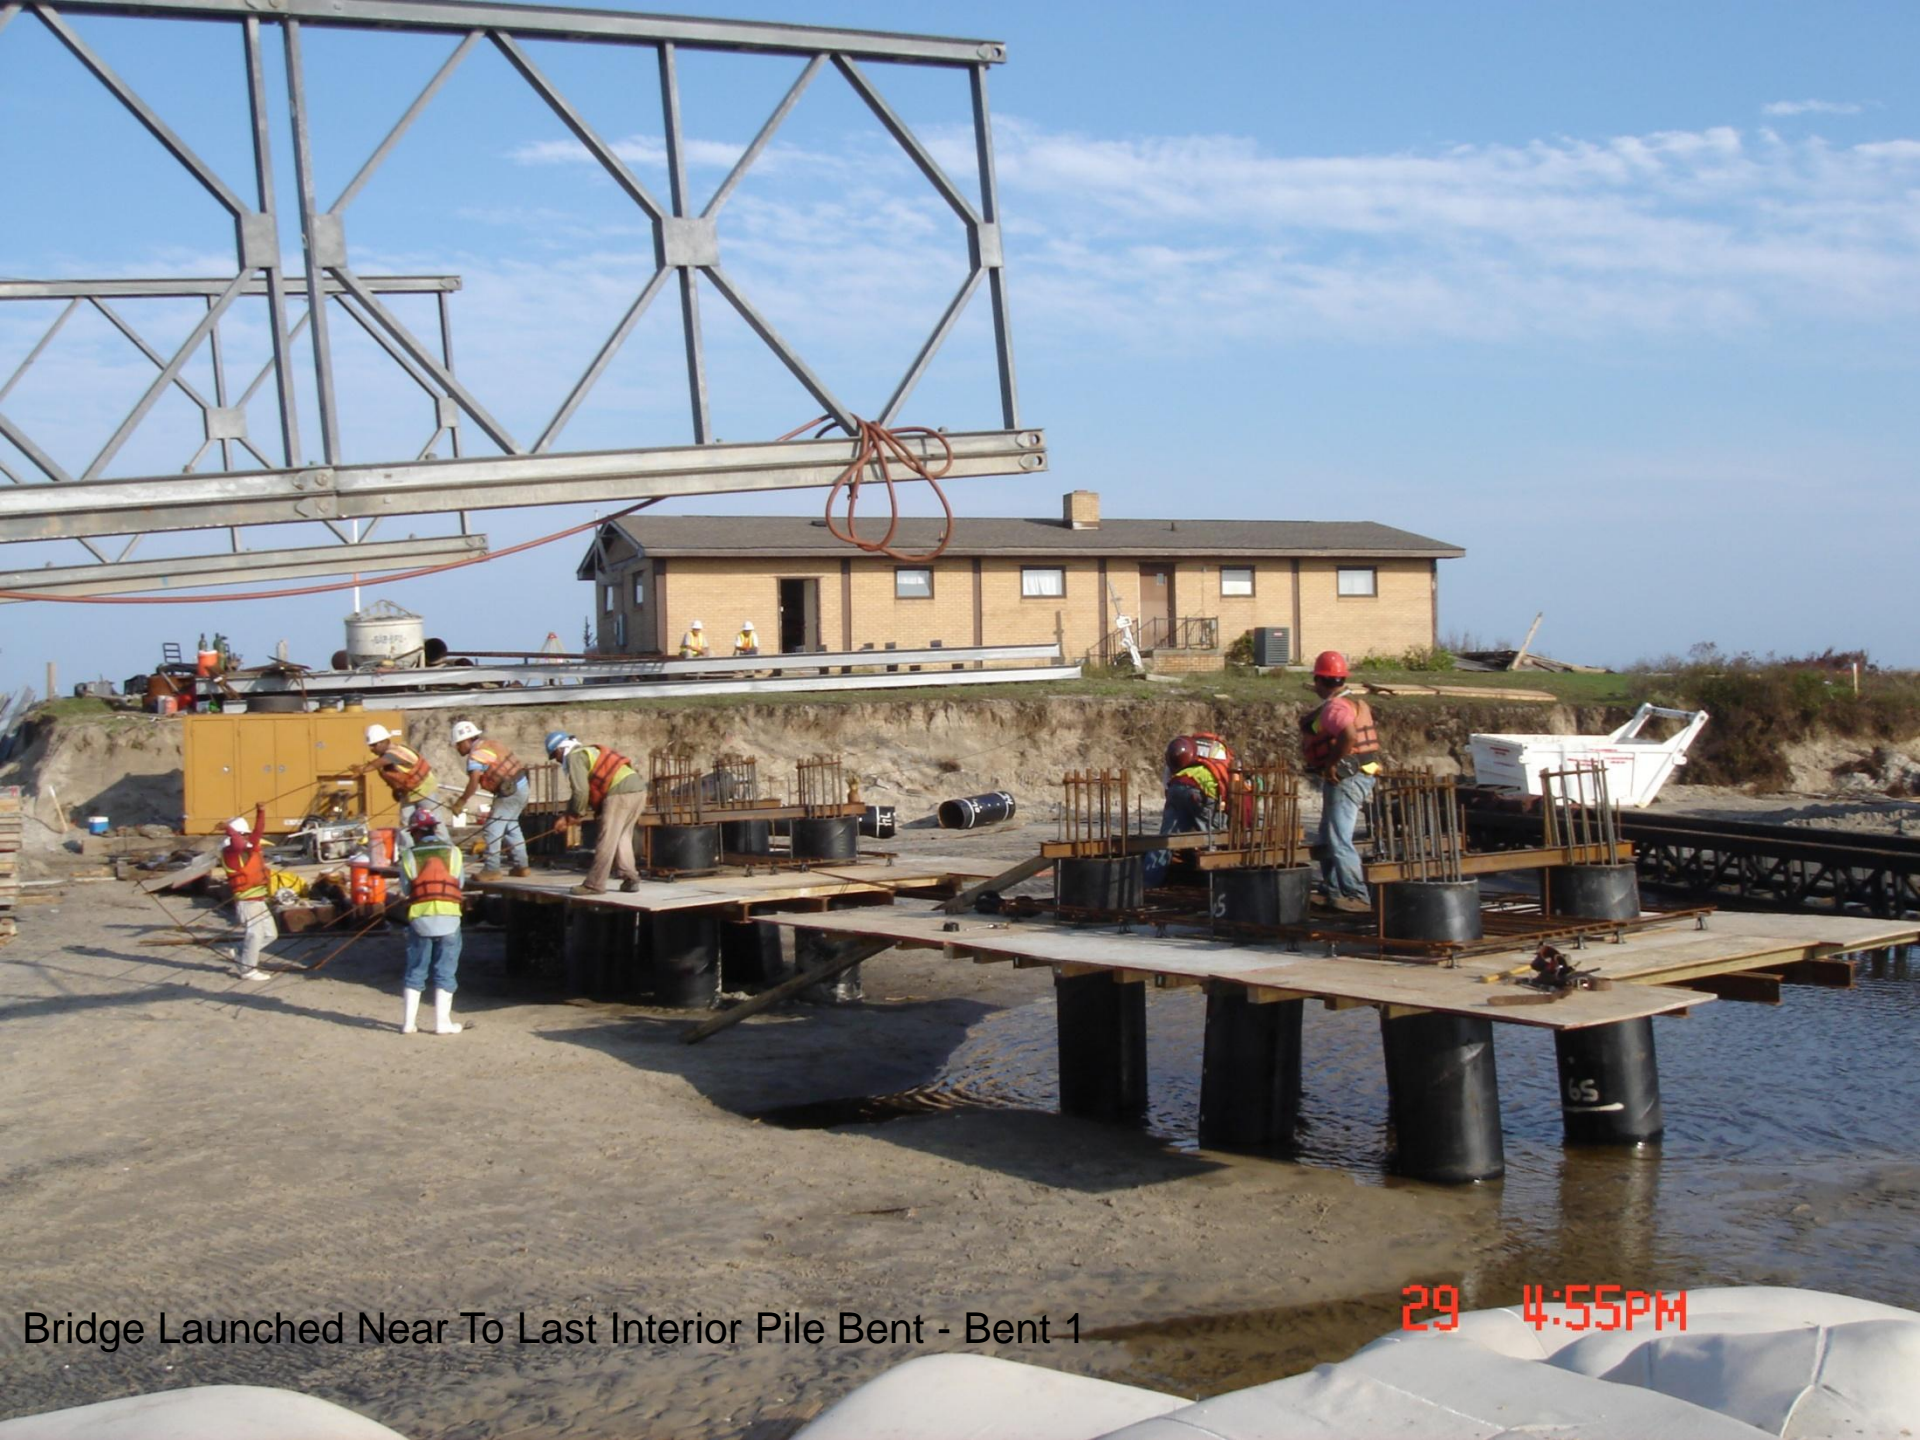
Bridge Launched Near To Last Interior Pile Bent - Bent 1

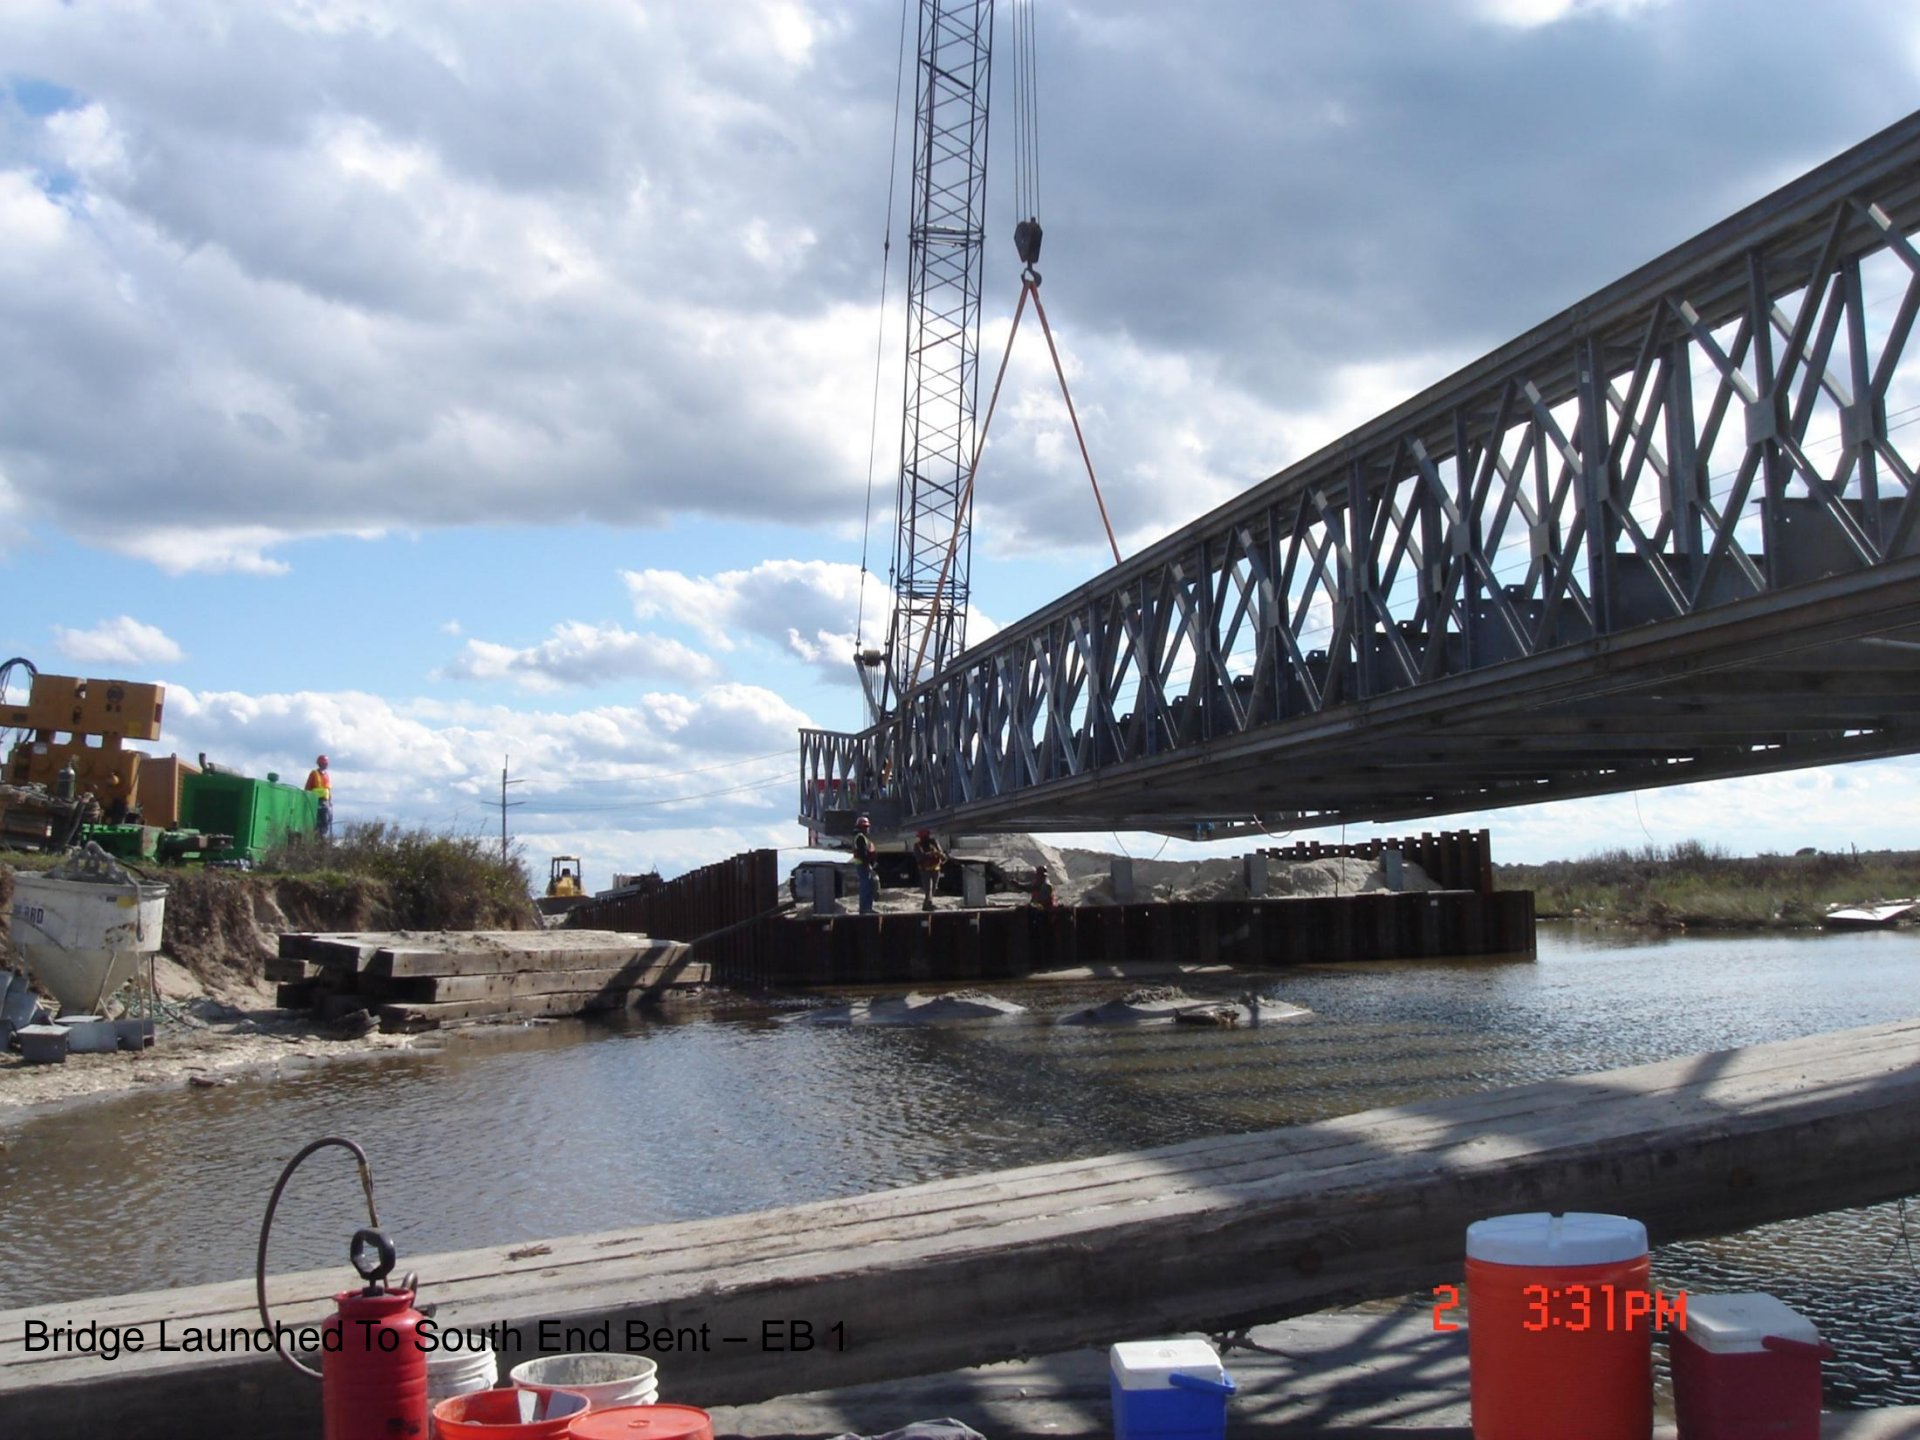
Bridge Launched To South End Bent – EB 1
