Project Information

Project Name: E911

Metadata Information

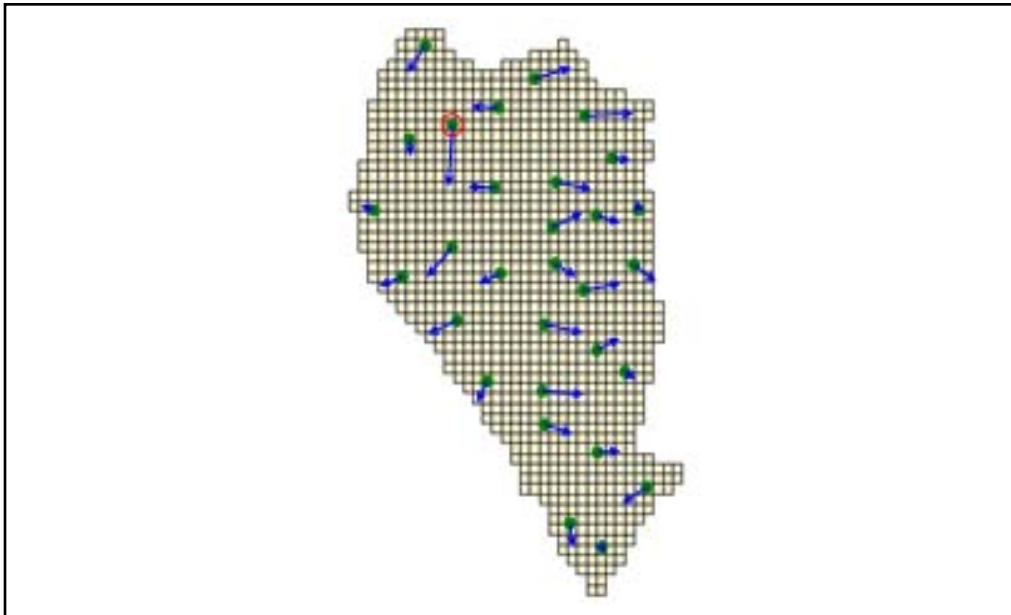
Vector Offset

Scaling Factor: 10000

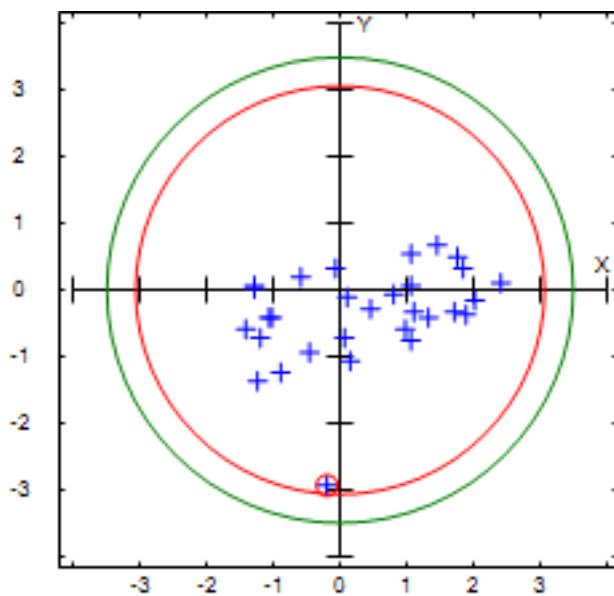
Circular Error

Min ΔX :	-1.411	Min ΔY :	-2.93	SX:	1.486
Max ΔX :	2.409	Max ΔY :	0.673	SY:	1.367
Mean ΔX :	0.353	Mean ΔY :	-0.365	SH:	1.427
Skew ΔX :	-0.028	Skew ΔY :	-1.618		
RmseX:	1.224	RmseY:	0.786	RmseH:	1.455
SRMSE H:	0.26				
CE 90:	3.061	CE 95:	3.492	CI:	0.511
No. Observations:	30				
Horiz. Bias:	0.507		NSSDA:	2.46

Threshold: CE90: 3.061
